CAR VEHICLE DESCRIPTION - Seat Ibiza FR 1.0 TSI

Inspection date:

22-12-2025

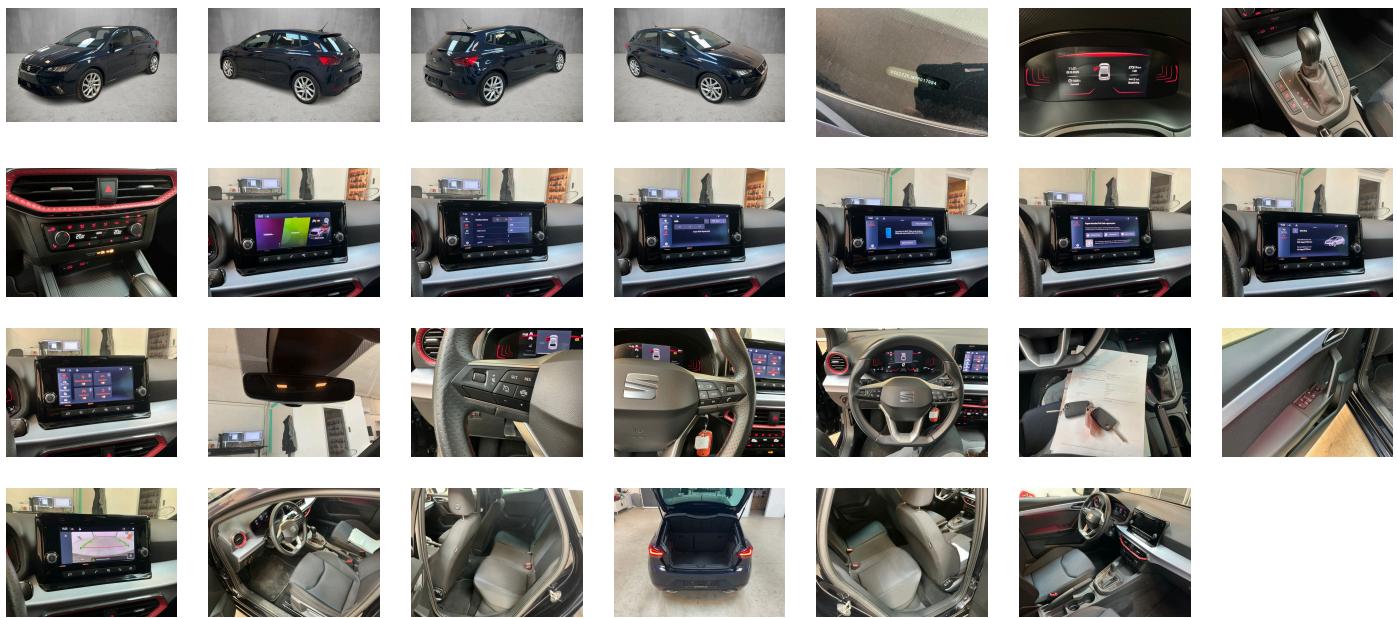
PICTURES

| Nº | LOCATION | TYPE | SEVERITY | INSURANCE | NOTES | DAMAGE GROUP |
| 1 | R. Front Rim | Scratch | C4 | | Reporting needed | |
| 2 | Front Bumper | Scratch | C4 | | Reporting needed | |
| 3 | L. Mirror | Scratch | C3 | | | |
| 4 | Rear Bumper | Scratch | C3 | | | |
