VEHICLE DESCRIPTION - Seat Arona Style 1.0 TSI

VEHICLE DETAILS

OVERVIEW OF DAMAGES AND SHORTAGES

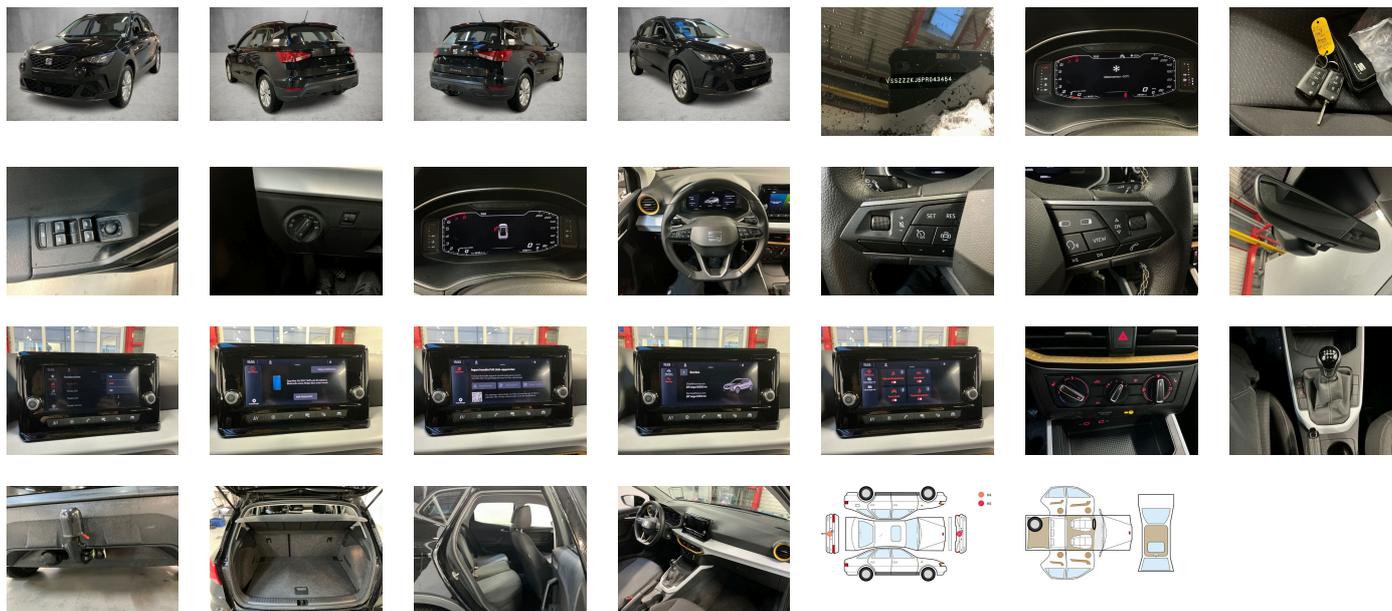
PICTURES

N°	LOCATION	TYPE	SEVERITY	INSURANCE	NOTES	DAMAGE GROUP
1	Front Bumper, Grill	Cracked	C5		Reporting needed

2	Front Bumper	Scratch	C4		Reporting needed

3	Rear Bumper	Scratch	C4		Reporting needed
