🚗 VEHICLE DESCRIPTION - Škoda Kamiq Life 1.0 TSI

🚗 SUMMARY OF THE VEHICLE'S CONDITION

OVERVIEW OF DAMAGES AND SHORTAGES

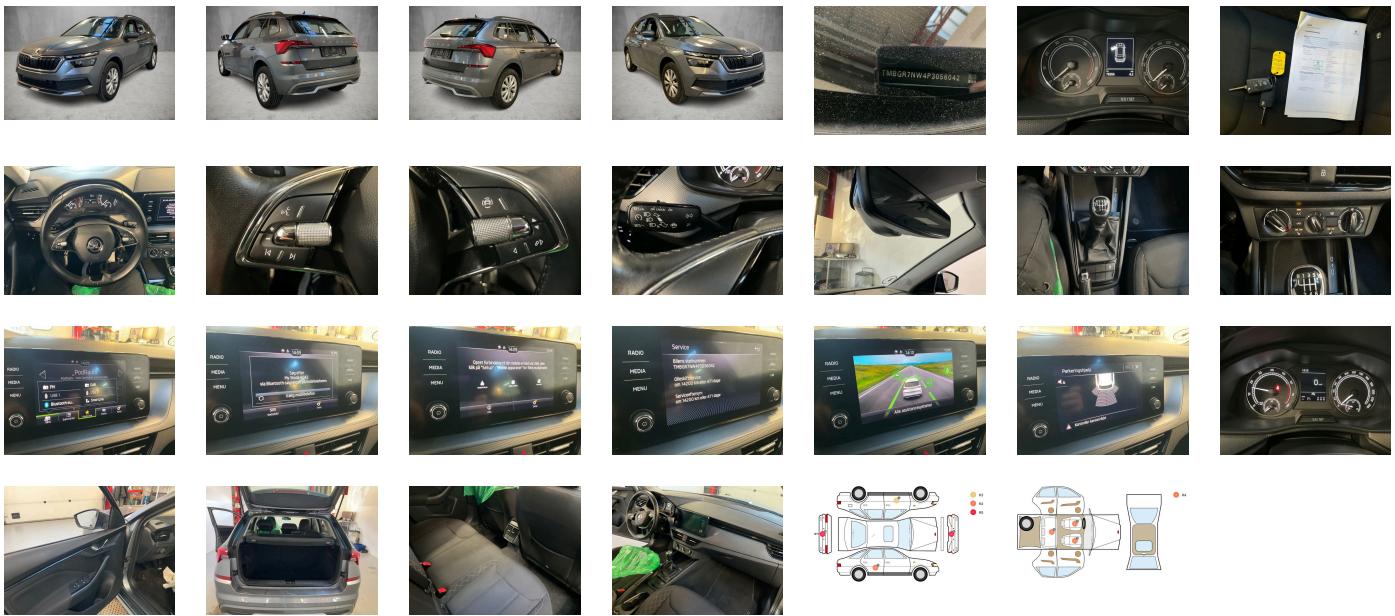
PICTURES

Nº	LOCATION	TYPE	SEVERITY	INSURANCE	NOTES	DAMAGE GROUP
1	Front Bumper, Spoiler	Dent	C5	Reporting done		Group 2

2	Rear Bumper, Rear Skirt	Scratch	C5	Reporting done		Group 1

3	Rear Seat	Discoloration	C4	Reporting needed

4	R. Rear Door	Scratch	C4	Reporting done

5	Passenger Seat	Discoloration	C4	Reporting needed

6	Front Bumper	Scratch	C4	Reporting done		Group 2

7	Drivers Seat	Discoloration	C4	Reporting needed

8	Rear Bumper	Scratch	C4	Reporting done		Group 1

9	L. Front door	Dent	C3
