₩ VEHICLE DESCRIPTION - Škoda Fabia Ambition 1.0 TSI

SUMMARY OF THE VEHICLE'S CONDITION

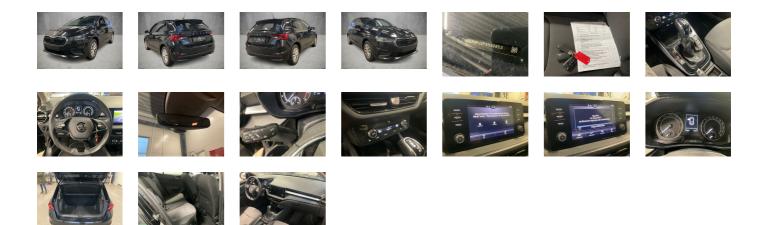
PICTURES

° LOCATION	TYPE	SEVERITY	INSURANCE	NOTES	DAMAGE GROUP
L. Rear Quarter F	PanelScratch	C4	Reporting needed		
R. Rear Quarter Panel	Dent	C4	Reporting needed		Group 1
Front Bumper	Scratch	C4	Reporting needed		
4 R. Rear Door	Scratch	C4	Reporting needed		Group 1
R. Front Rim	Scratch	C4	Reporting needed		
5 R. Rear Rim	Scratch	C3			
Severity explanation C0 = No damage / replacement		paration / C2 = Min	or preparation neede	d / C3 = Can be smart repaired / C4 = R	epair/spray paint / C5 = Need
