VEHICLE DESCRIPTION - Seat Ibiza FR 1.0 MPI

SUMMARY OF THE VEHICLE'S CONDITION

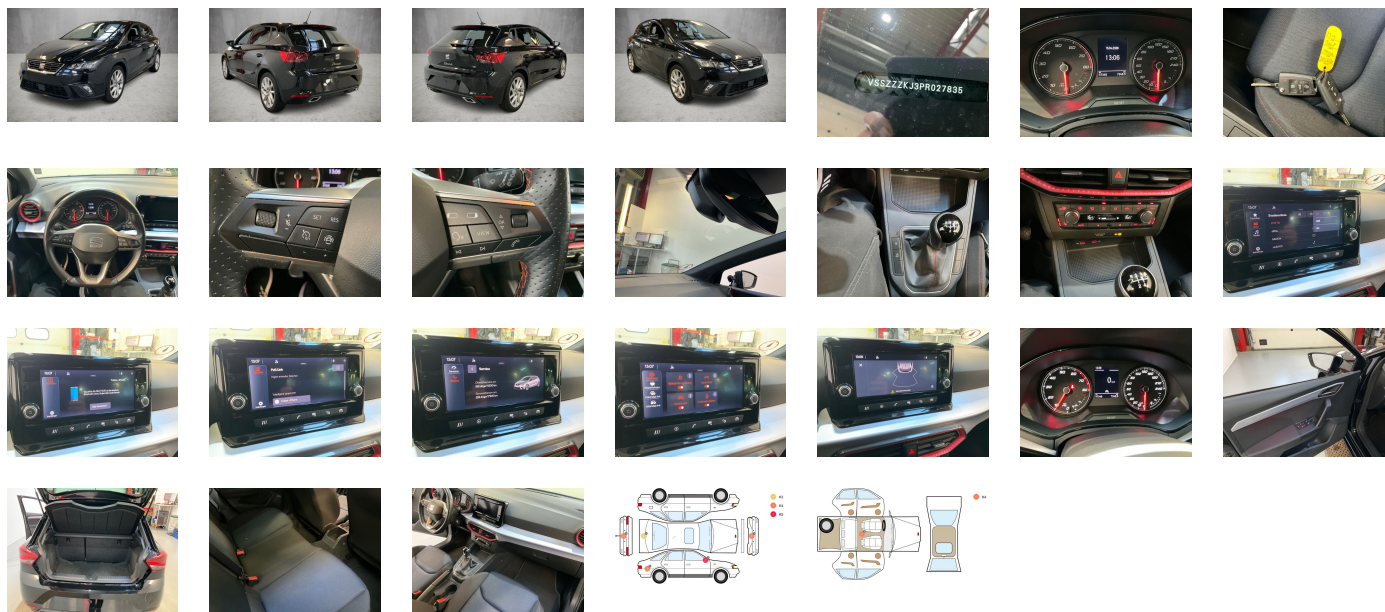
## PICTURES

| N° | LOCATION | TYPE | SEVERITY | INSURANCE | NOTES | DAMAGE GROUP |
|---|---|---|---|---|---|---|
| 1 | R. Mirror, Casing | Missing | C5 | Reporting needed | | |
| 2 | R. Rear Quarter Panel | Dent | C4 | Reporting needed | | |
| 3 | Rear Bumper | Dent | C4 | Reporting needed | Forbehold for skade under bagkofanger | |
| 4 | Front Bumper | Scratch | C4 | Reporting needed | | |
| 5 | Cabin | Odors | C4 | Reporting needed | Røglugt | |
| 6 | Floor Cover | Burn Mark | C4 | Reporting needed | | |
| 7 | Rear Hood | Dent | C3 | | | |
