VEHICLE DESCRIPTION - VW Polo Life 1.0 TSI

Inspection date:
18-05-2026

SUMMARY OF THE VEHICLE'S CONDITION

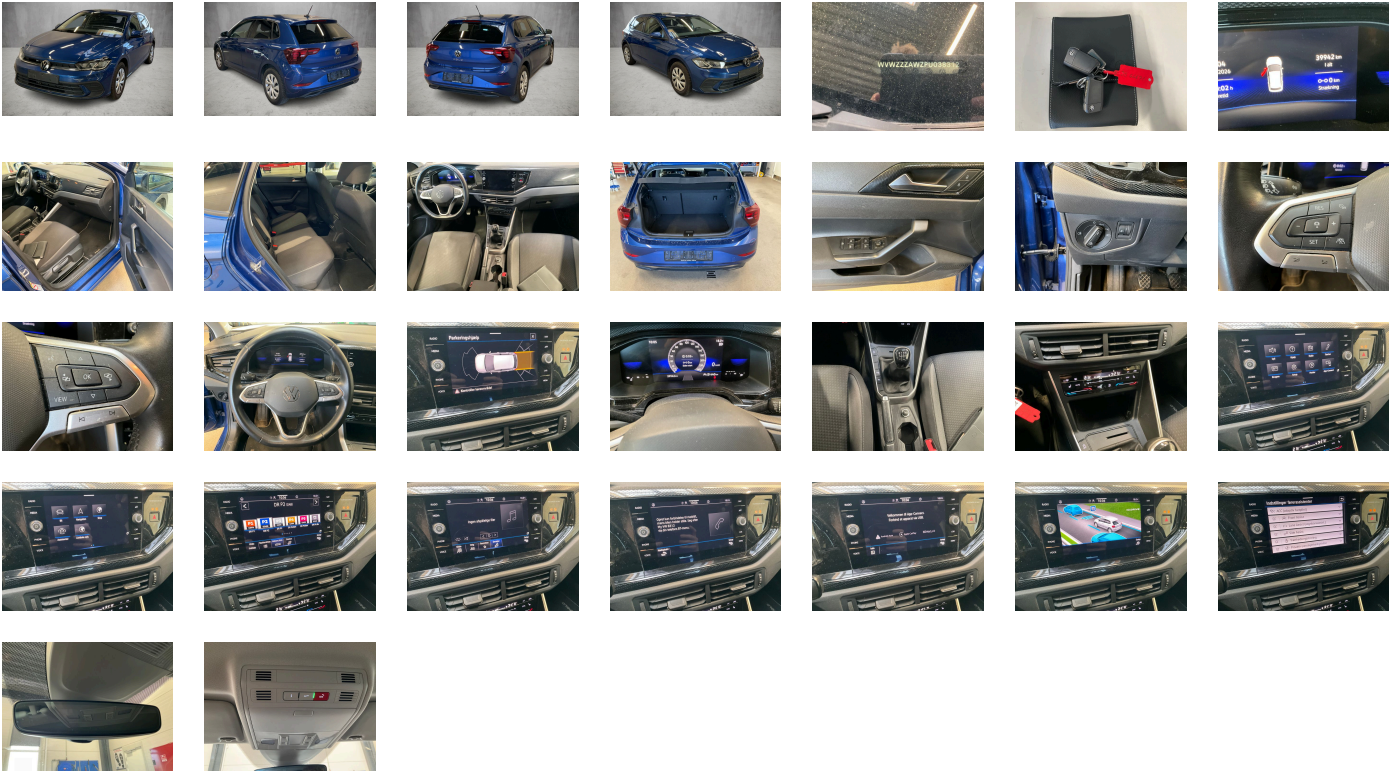
PICTURES

N°	LOCATION	TYPE	SEVERITY	INSURANCE	NOTES	DAMAGE GROUP
1	Front Bumper	Cracked	C5		Reporting needed

2	Rear Bumper	Scratch	C4		Reporting needed

3	R. Rear Door	Dent	C3
