CAR VEHICLE DESCRIPTION - Škoda Scala Blackline 1.5 TSI

PICTURES

OVERVIEW OF DAMAGES AND SHORTAGES

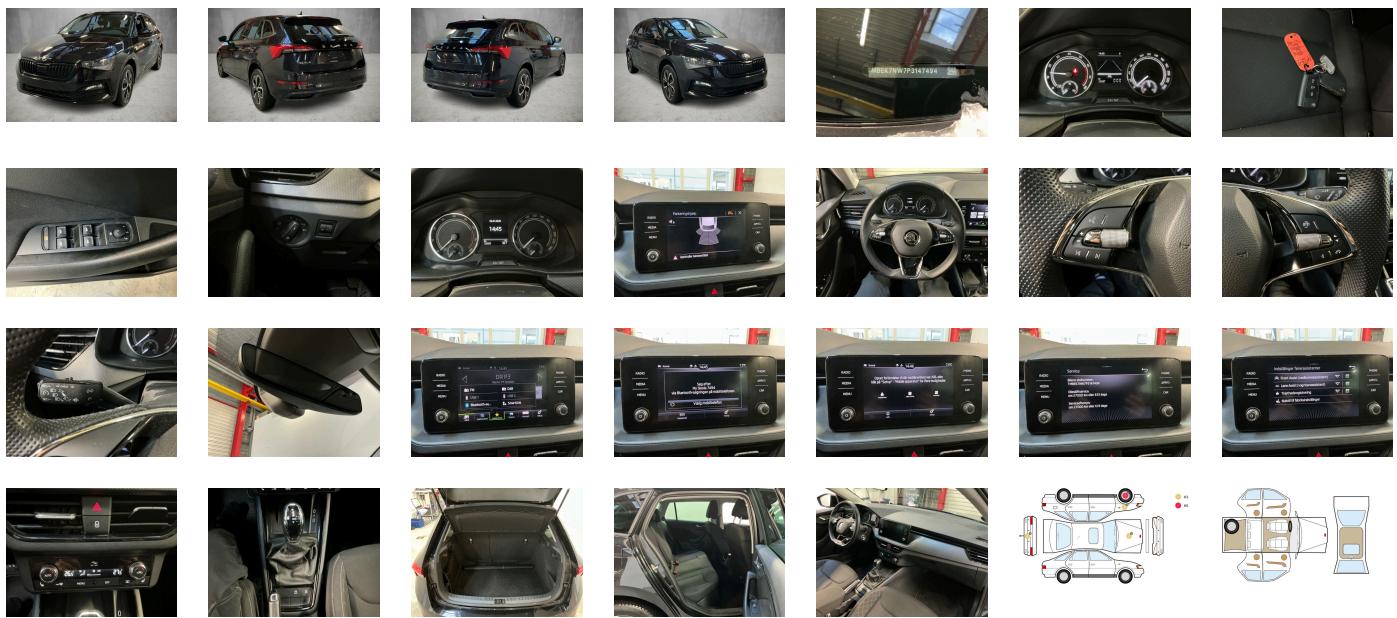
Nº	LOCATION	TYPE	SEVERITY	INSURANCE	NOTES	DAMAGE GROUP
1	L. Front Rim	Scratch	C5		Reporting needed	
2	Hood	Dent	C3			
3	L. Front Quarter Panel	Scratch	C3			
4	Rear Bumper	Scratch	C3
