VEHICLE DESCRIPTION - Škoda Superb Style 1.5 TSI ACT

SUMMARY OF THE VEHICLE'S CONDITION

## OVERVIEW OF DAMAGES AND SHORTAGES

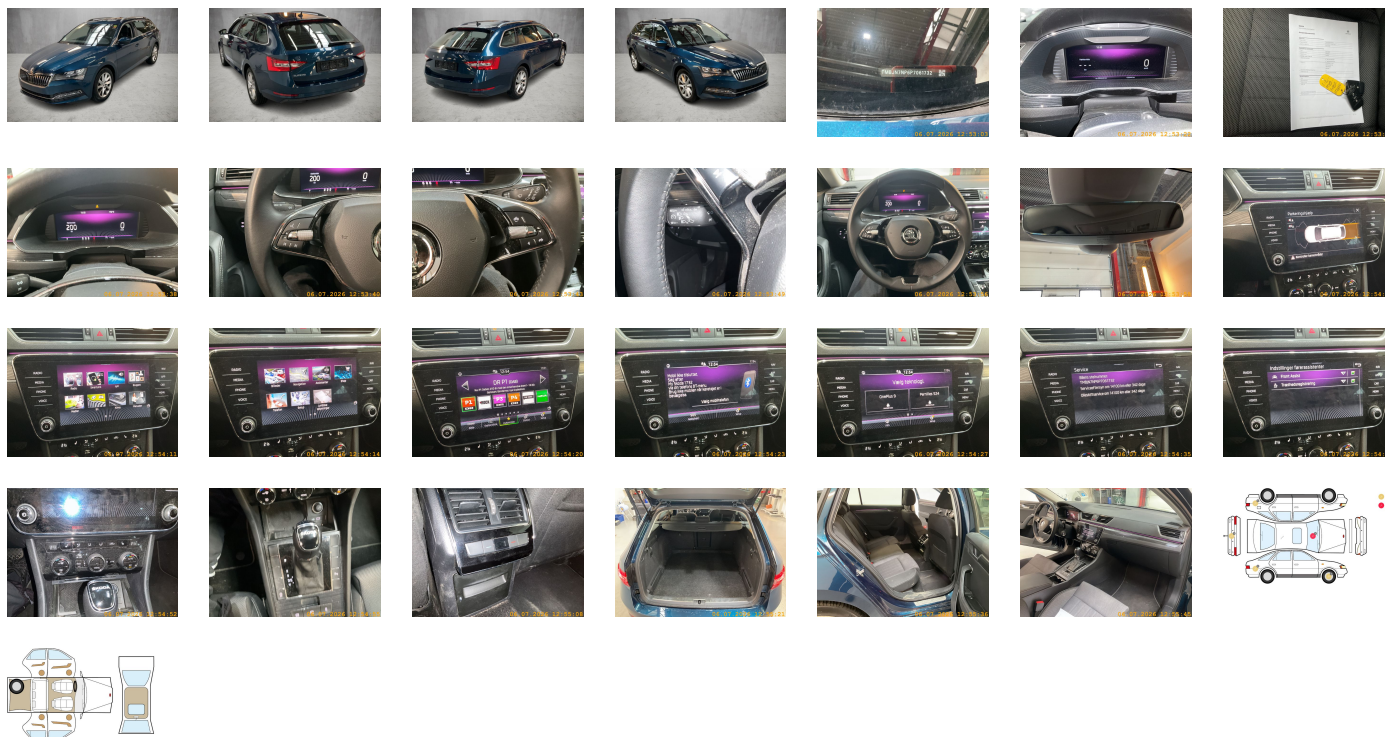
## PICTURES

| N° | LOCATION | TYPE | SEVERITY | INSURANCE | NOTES | DAMAGE GROUP |
|---|---|---|---|---|---|---|
| 1 | Front Windscreen | Stone Chips | C5 | Reporting needed | | |
| 2 | Rear Bumper | Scratch | C3 | | | |
| 3 | R. Front Rim | Scratch | C3 | | | |
| 4 | L. Rear Quarter Panel | Dent | C3 | | | |
| 5 | R. Rear Quarter Panel | Scratch | C3 | | | |
