VEHICLE DESCRIPTION - Seat Ibiza FR 1.0 MPI

SUMMARY OF THE VEHICLE'S CONDITION

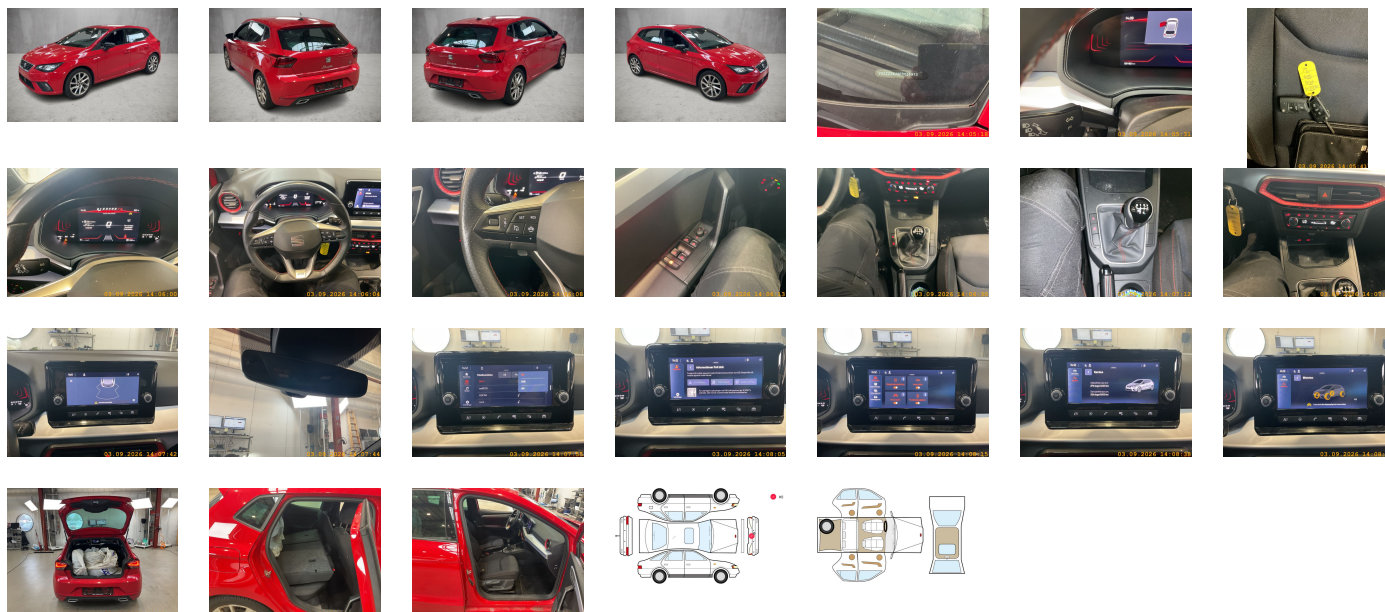
| N° | LOCATION | TYPE | SEVERITY | INSURANCE | NOTES | DAMAGE GROUP |
|---|---|---|---|---|---|---|
| 1 | Front Bumper | Cracked | C5 | Reporting needed | Radar ligger løs bagved | |

| N° | LOCATION | TYPE | NOTES |
|---|---|---|---|
| 2 | Combined instrument | Lights | Fejl frontradar |
