VEHICLE DESCRIPTION - Seat Ibiza Style 1.0 MPI

SUMMARY OF THE VEHICLE'S CONDITION

## OVERVIEW OF DAMAGES AND SHORTAGES

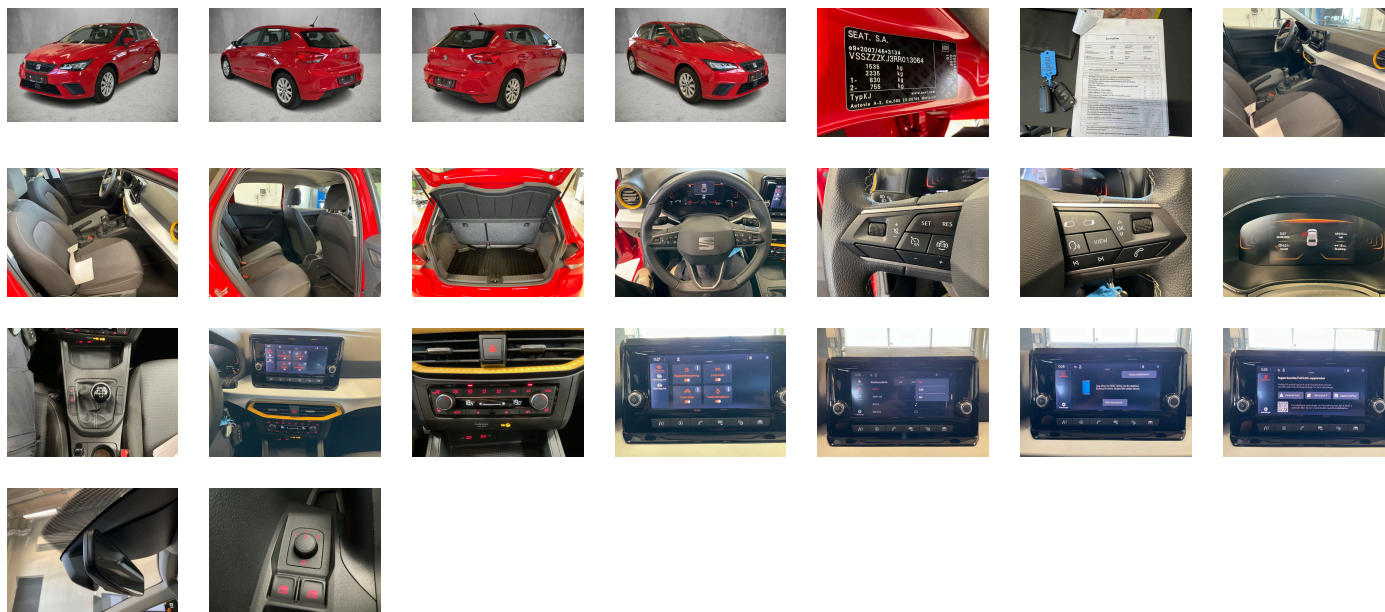
## PICTURES

| N° | LOCATION | TYPE | SEVERITY | INSURANCE | NOTES | DAMAGE GROUP |
|---|---|---|---|---|---|---|
| 1 | R. Rear Quarter Panel | Scratch | C4 | | Reporting needed | |
| 2 | R. Front Door, Handle | Scratch | C4 | | Reporting needed | |
| 3 | R. Rear Quarter Panel | Dent | C4 | | Reporting needed | |
| 4 | Rear Bumper | Scratch | C4 | | Reporting needed | |
| 5 | Hood | Stone Chips | C3 | | | |
| 6 | R. Rear Door, Handle Scratch | | C3 | | | |
| 7 | L. Rear Door | Scratch | C3 | | | |
| 8 | L. Front door | Scratch | C3 | | | |
