VEHICLE DESCRIPTION - Škoda Scala Life 1.0 TSI

SUMMARY OF THE VEHICLE'S CONDITION

## OVERVIEW OF DAMAGES AND SHORTAGES

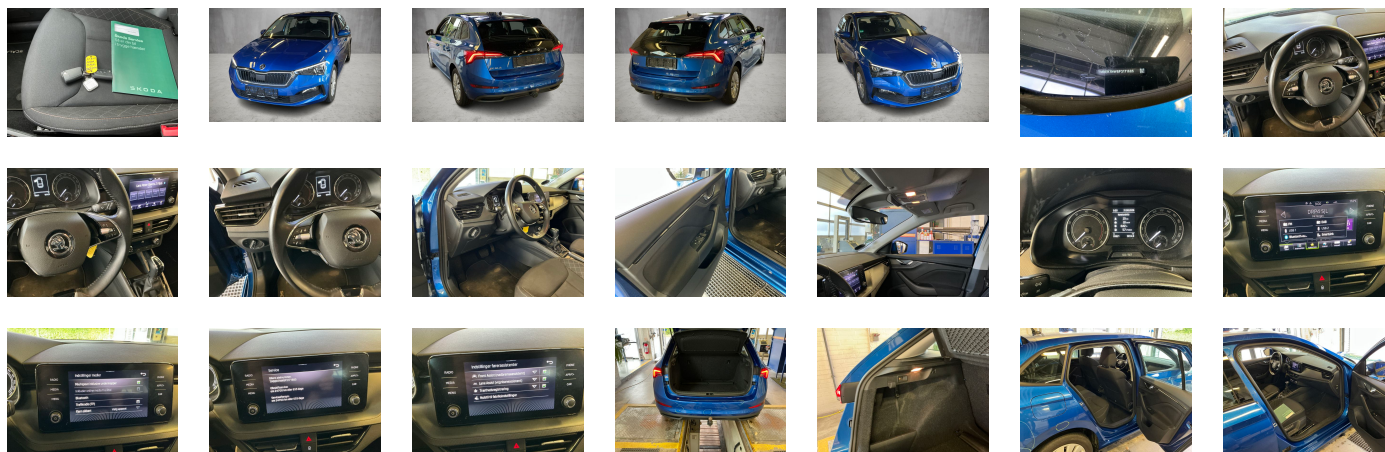
## PICTURES

| N° | LOCATION | TYPE | SEVERITY | INSURANCE | NOTES | DAMAGE GROUP |
|---|---|---|---|---|---|---|
| 1 | Front Windscreen | Stone Chips | C5 | Reporting needed | | |
| 2 | R. Rear Quarter Panel | Dent | C4 | Reporting needed | | Group 1 |
| 3 | Rear Bumper | Scratch | C4 | Reporting needed | | Group 1 |
| 4 | Rear Bumper | Scratch | C4 | Reporting needed | | Group 1 |
| 5 | R. Rear Quarter Panel | Dent | C4 | Reporting needed | | Group 1 |
| 6 | Front Windscreen | Wear and tear | C3 | Reporting needed | | |
| 7 | Front Bumper | Scratch | C3 | | | |
| 8 | Front Bumper | Scratch | C3 | | | |
| 9 | Front Windscreen | Wear and tear | C3 | Reporting needed | | |
