VEHICLE DESCRIPTION - Seat Arona FR 1.0 TSI

VEHICLE DETAILS

SUMMARY OF THE VEHICLE'S CONDITION

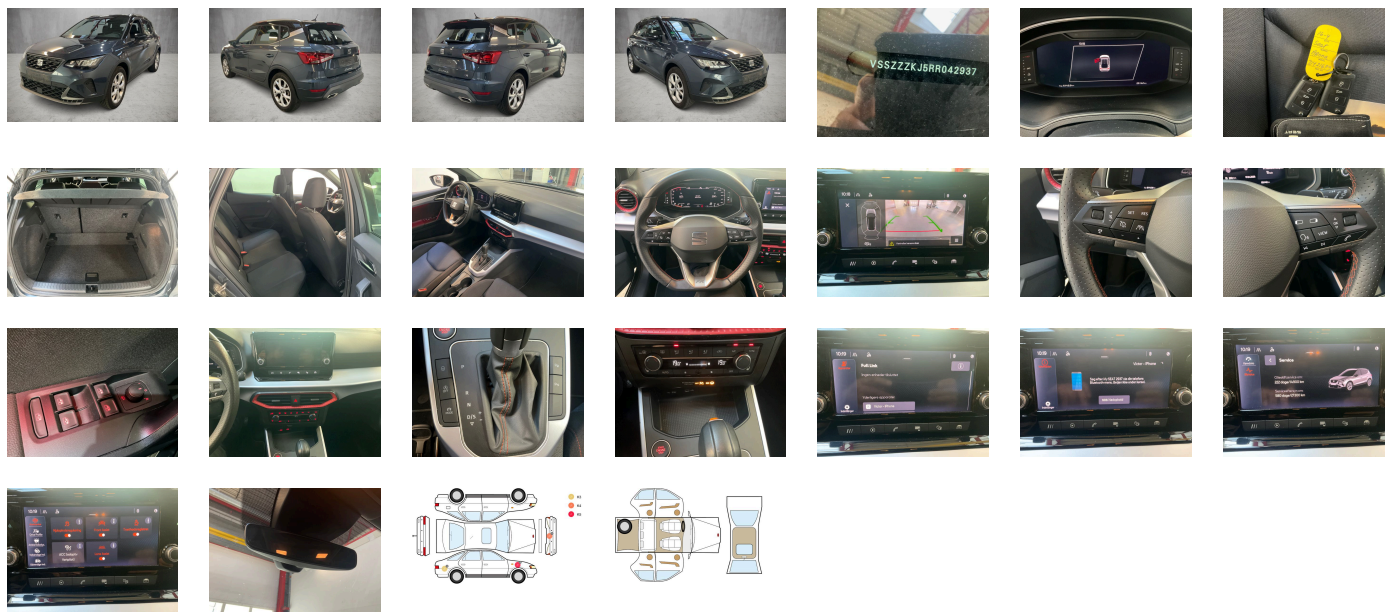
PICTURES

N°	LOCATION	TYPE	SEVERITY	INSURANCE	NOTES	DAMAGE GROUP
1	R. Front Quarter Panel, List

Scratch	C5		Reporting needed	Group 1
2	Front Bumper

Scratch	C4		Reporting needed	
3	R. Front Quarter Panel

Dent	C4		Reporting needed	Group 1
4	R. Rear Quarter Panel

Dent	C3
