CAR VEHICLE DESCRIPTION - Škoda Scala Essence 1.0 TSI

OVERVIEW OF DAMAGES AND SHORTAGES

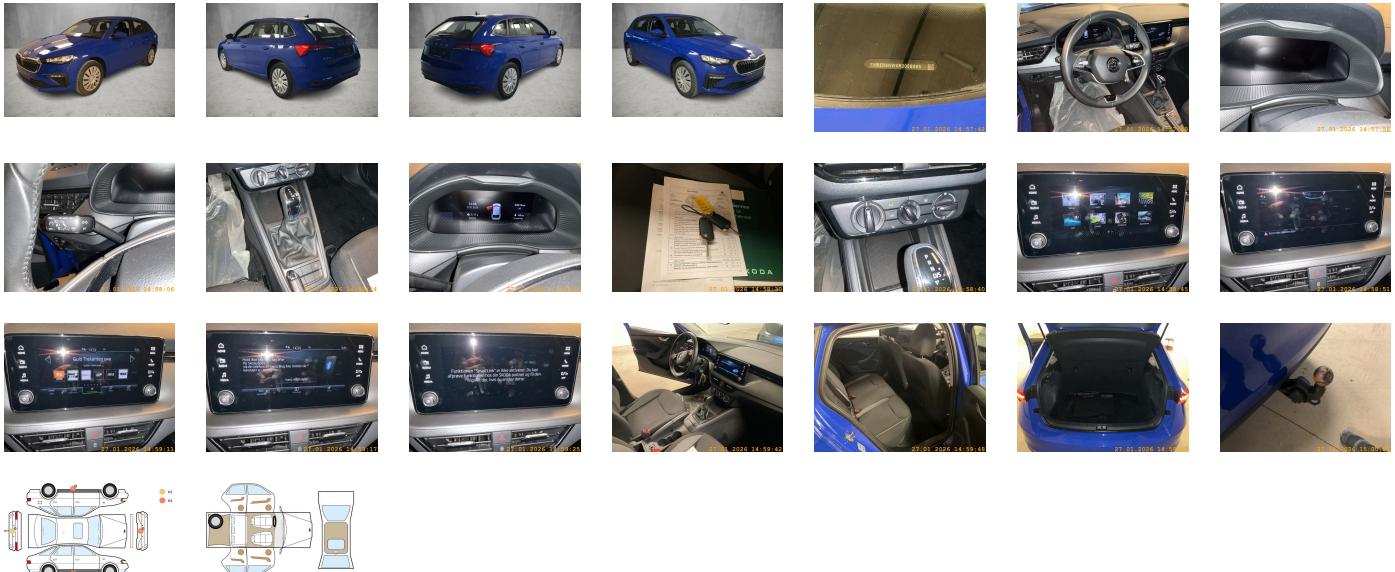
PICTURES

Nº	LOCATION	TYPE	SEVERITY	INSURANCE	NOTES	DAMAGE GROUP
1	L. Rocker Panel	Dent	C4		Reporting done

2	Front Bumper	Scratch	C4		Reporting done

3	R. Rocker Panel	Dent	C4		Reporting done

4	Rear Bumper	Scratch	C3
