VEHICLE DESCRIPTION - Škoda Karoq Selection 1.0 TSI

SUMMARY OF THE VEHICLE'S CONDITION

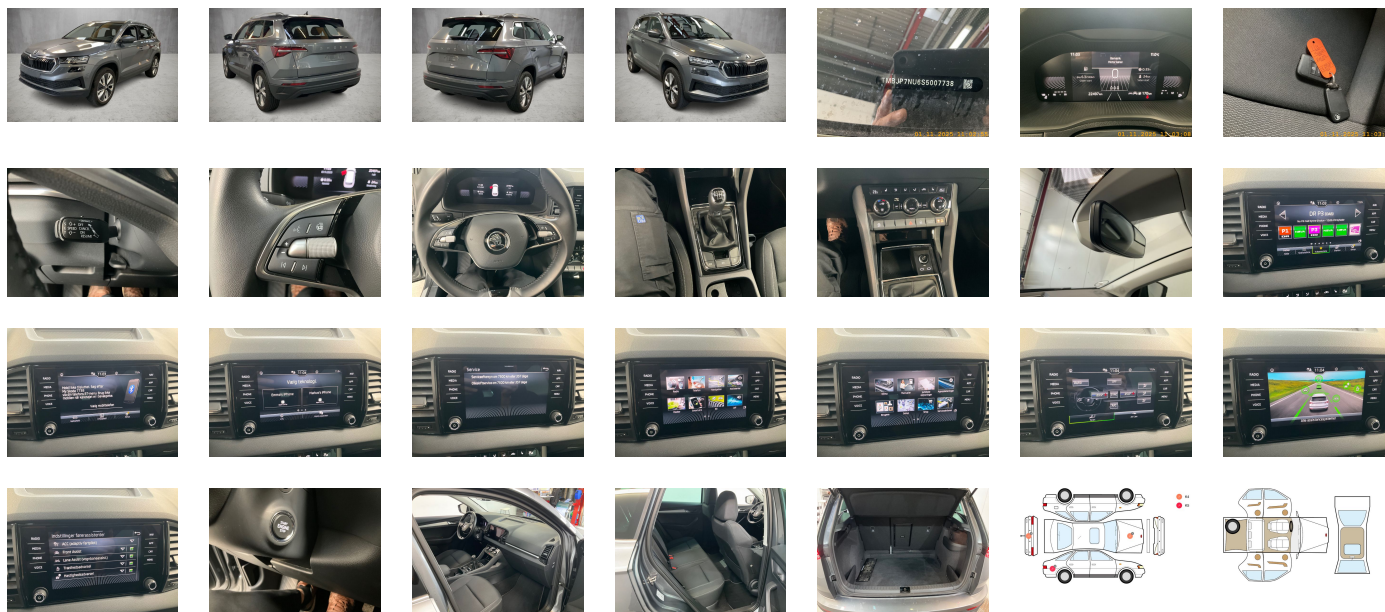
## PICTURES

| N° | LOCATION | TYPE | SEVERITY | INSURANCE | NOTES | DAMAGE GROUP |
|---|---|---|---|---|---|---|
| 1 | R. Rear Quarter Panel, List | Scratch | C5 | Reporting done | | Group 1 |
| 2 | Rear Bumper | Scratch | C4 | Reporting done | | Group 1 |
| 3 | R. Rear Quarter Panel | Dent | C4 | Reporting done | | Group 1 |
| 4 | Hood | Dent | C4 | Reporting needed | | |
| 5 | Rear Bumper, Rear Skirt | Scratch | C4 | Reporting done | | Group 1 |
