→ VEHICLE DESCRIPTION - Seat Ibiza FR 1.0 Eco TSI

SUMMARY OF THE VEHICLE'S CONDITION

OVERVIEW OF DAMAGES AND SHORTAGES

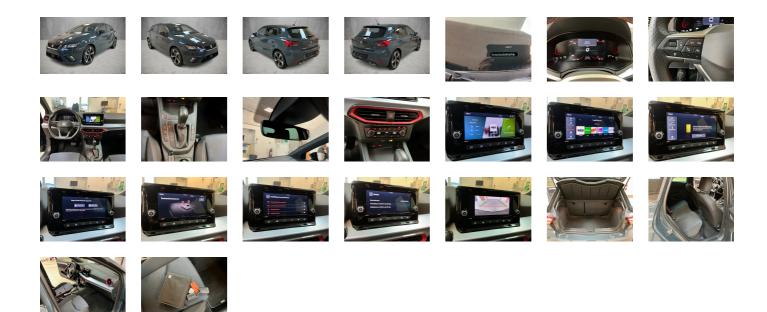
PICTURES

N°	LOCATION	TYPE	SEVERITY	INSURANCE	NOTES	DAMAGE GROUP
1	R. Front Rim	Scratch	C5	Reporting needed		
2	Rear Seat	Discolorati on	C4	Reporting needed		
_	R. Rear Quarter Panel	Dent	C3			
	Severity explanation	on:
