🚗 VEHICLE DESCRIPTION - Škoda Karoq Selection 1.0 TSI

OVERVIEW OF DAMAGES AND SHORTAGES

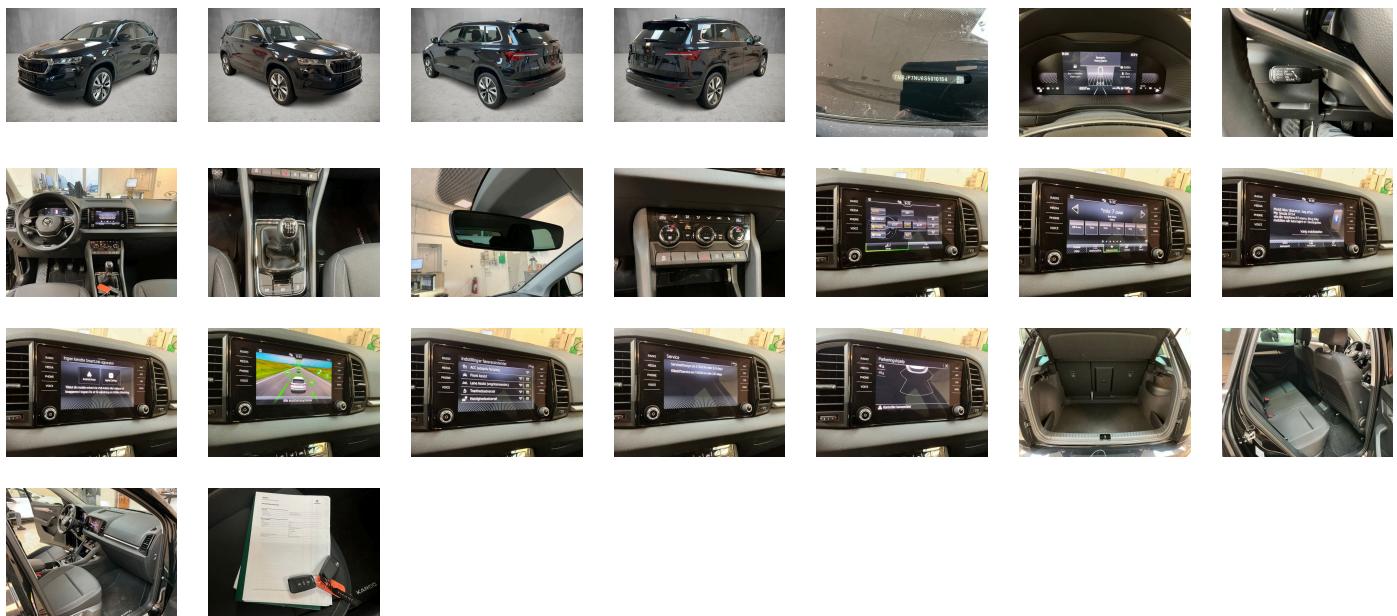
PICTURES

Nº	LOCATION	TYPE	SEVERITY	INSURANCE	NOTES	DAMAGE GROUP
1	L. Rocker Panel, Inside	Scratch	C3

2	L. Rear Door	Stone Chips	C3

3	R. Rocker Panel, Inside	Scratch	C3

4	R. Rear Door	Dent	C3

5	Rear Bumper	Scratch	C3
