VEHICLE DESCRIPTION - Škoda Kamiq Selection 1.0 TSI

Inspection date:
23-01-2026

SUMMARY OF THE VEHICLE'S CONDITION

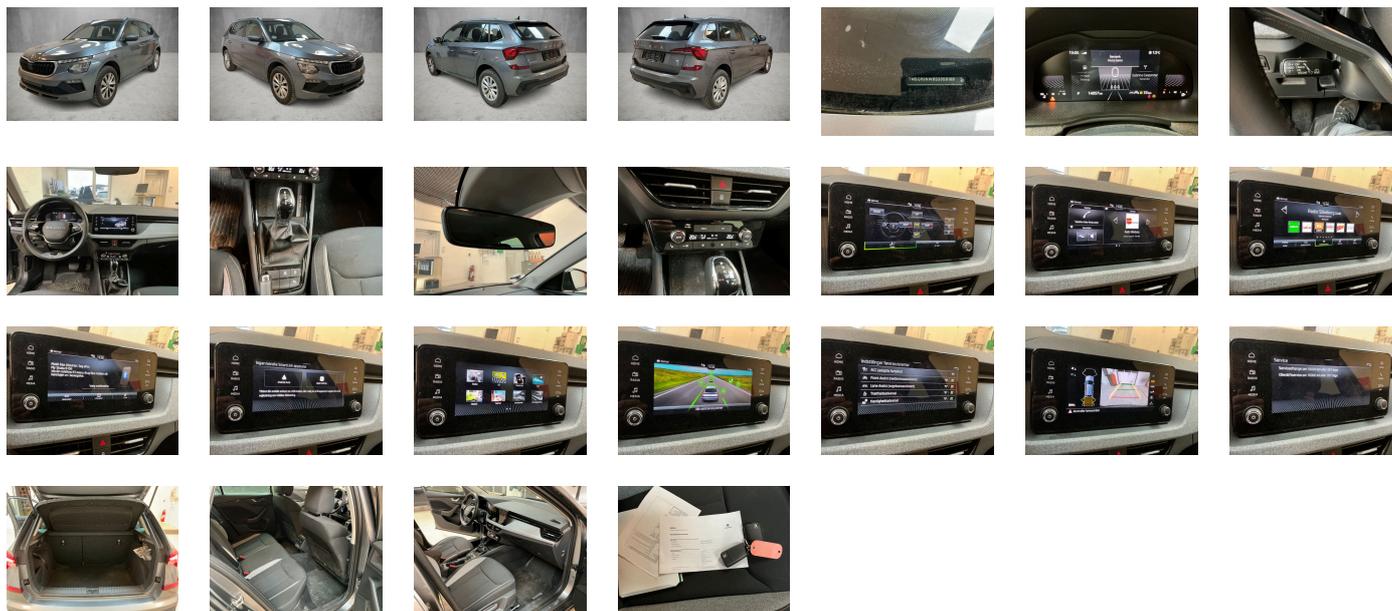
PICTURES

N°	LOCATION	TYPE	SEVERITY	INSURANCE	NOTES	DAMAGE GROUP
1	Front Windscreen	Cracked	C5		Reporting needed

2	Passenger Seat	Discoloration	C4		Reporting needed

3	Cabin	Cleaning	C4		Reporting needed

4	R. Mirror, Casing	Scratch	C3

5	Rear Bumper	Scratch	C3

6	R. Front Door, Handle	Paint Flaking	C3
