🚗 VEHICLE DESCRIPTION - Škoda Kamiq Selection 1.0 TSI

OVERVIEW OF DAMAGES AND SHORTAGES

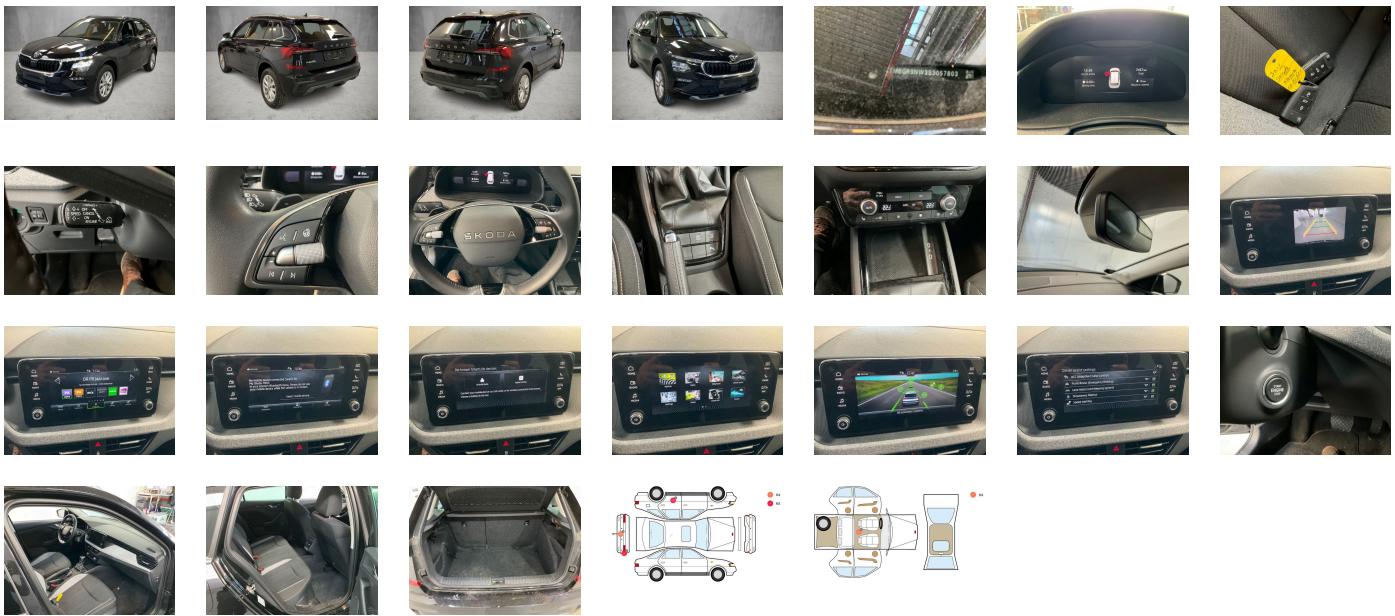
PICTURES

Nº	LOCATION	TYPE	SEVERITY	INSURANCE	NOTES	DAMAGE GROUP		
1	R. Rear Light	Scratch	C5		Reporting needed	Group 1

2	L. Rear Door	Dent	C5		Reporting needed

3	Cabin	Cleaning	C4		Reporting needed

4	Rear Bumper	Scratch	C4		Reporting needed	Group 1
