VEHICLE DESCRIPTION - VW Polo 2.0 TSI GTI

SUMMARY OF THE VEHICLE'S CONDITION

OVERVIEW OF DAMAGES AND SHORTAGES

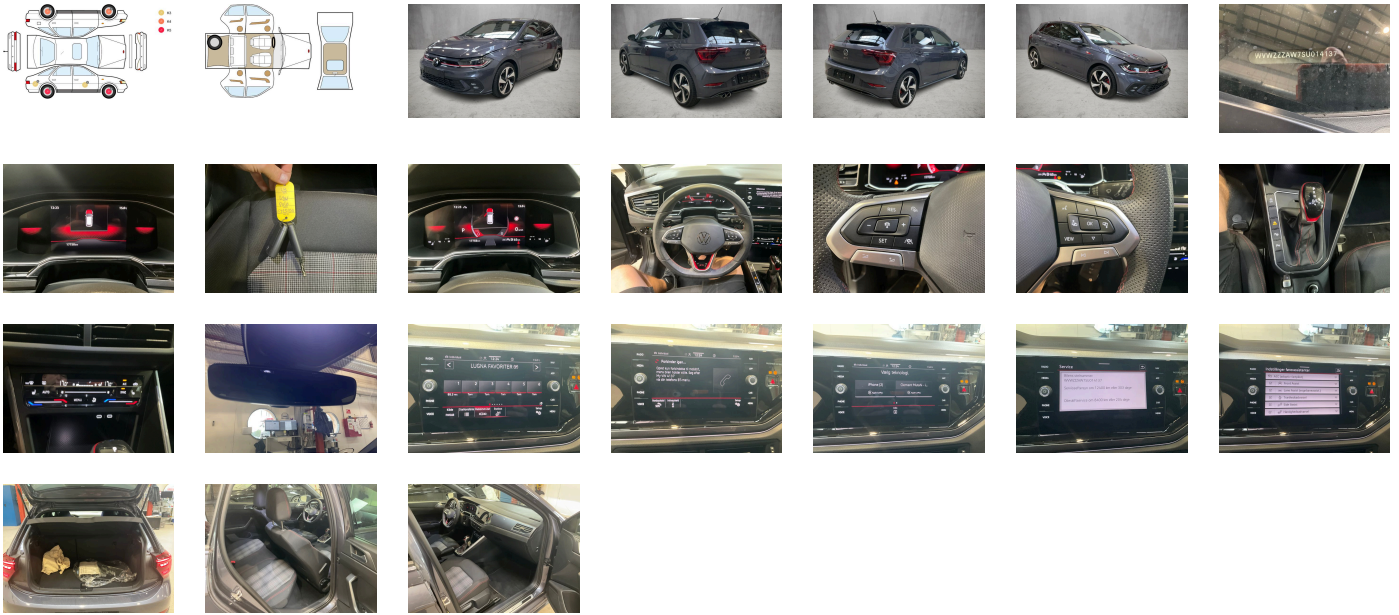
PICTURES

N°	LOCATION	TYPE	SEVERITY	INSURANCE	NOTES	DAMAGE GROUP
1	R. Front Tyre	Cracked	C5		Reporting needed	Group 2

2	R. Rear Tyre	Cracked	C5		Reporting needed	Group 1

3	R. Front Rim	Scratch	C4		Reporting needed	Group 2

4	L. Rear Rim	Scratch	C4		Reporting needed

5	L. Front Rim	Scratch	C4		Reporting needed

6	R. Front Door	Dent	C3

7	R. Rear Quarter Panel	Dent	C3

8	R. Rear Rim	Scratch	C3			Group 1
