VEHICLE DESCRIPTION - VW Taigo Style Plus 1.5 TSI

OVERVIEW OF DAMAGES AND SHORTAGES

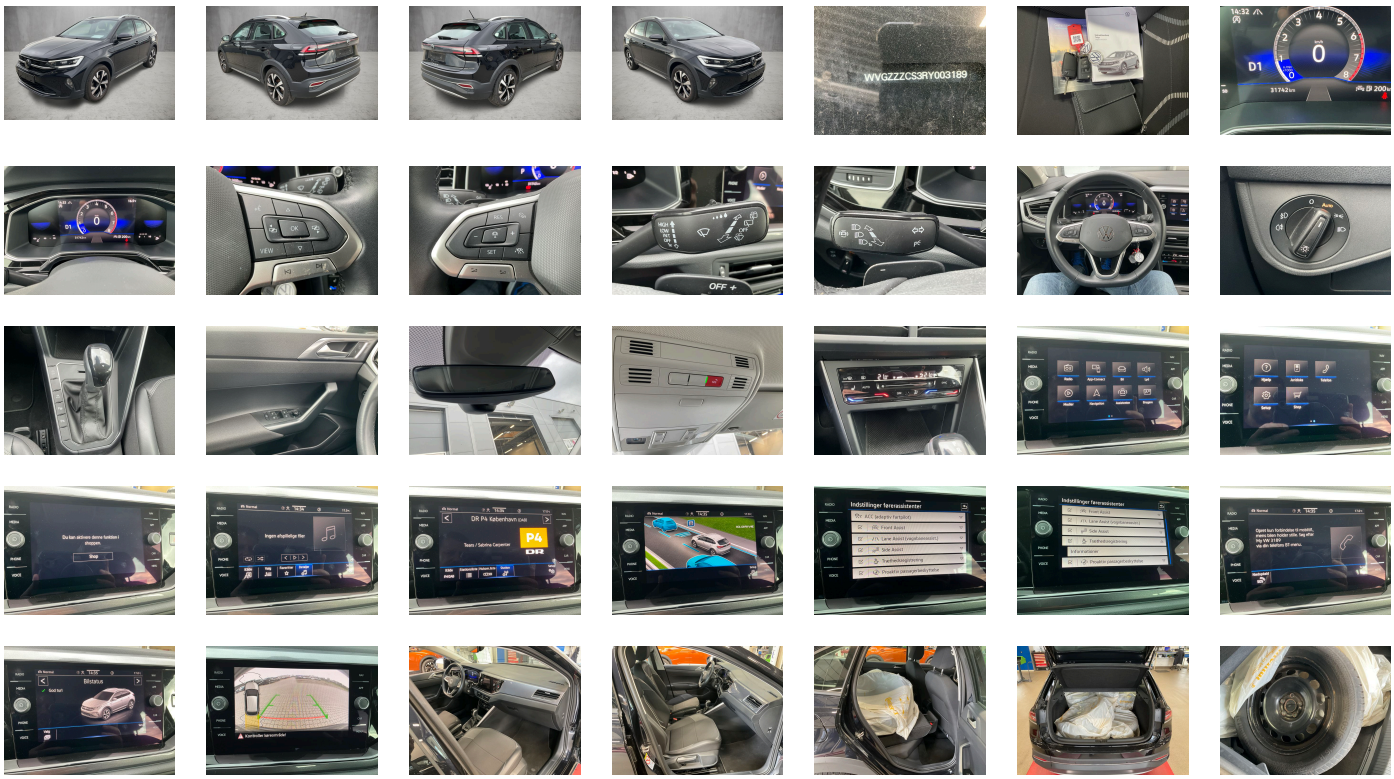
WHEELS

TYPE	SEASON	BRAND	POSITION	RIM	SIZE	TREAD
Fitted	Summer tires		Front Left	Alloy rim	17''	6 mm
Fitted	Summer tires		Rear Left	Alloy rim	17''	7 mm
Fitted	Summer tires		Rear Right	Alloy rim	17''	7 mm
Fitted	Summer tires		Front Right	Alloy rim	17''	6 mm
Extra Wheel	Winter tires		Rear Right	Steel rim	16''	8 mm
Extra Wheel	Winter tires		Rear Left	Steel rim	16''	8 mm
Extra Wheel	Winter tires		Front Left	Steel rim	16''	8 mm
Extra Wheel	Winter tires		Front Right	Steel rim	16''	8 mm

Legal tire tread (minimum 1.6 mm):
Yes
