VEHICLE DESCRIPTION - VW Touran Highline 1.5 TSI

SUMMARY OF THE VEHICLE'S CONDITION

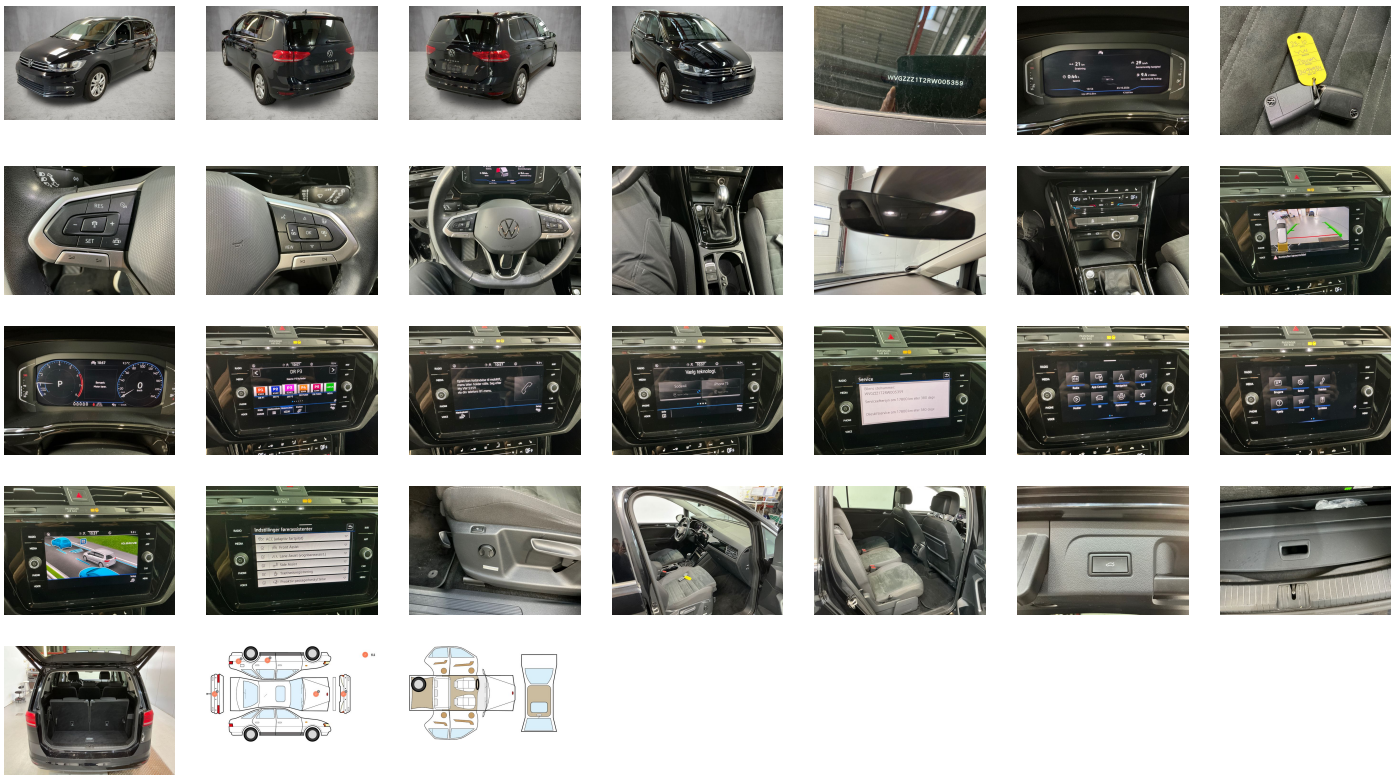
WHEELS

TYPE	SEASON	BRAND	POSITION	RIM	SIZE	TREAD
Fitted	Summer tires		Front Left	Alloy rim	16''	5 mm
Fitted	Summer tires		Rear Right	Alloy rim	16''	5 mm
Fitted	Summer tires		Rear Left	Alloy rim	16''	5 mm
Fitted	Summer tires		Front Right	Alloy rim	16''	5 mm

Legal tire tread (minimum 1.6 mm):
Yes
