VEHICLE DESCRIPTION - Škoda Fabia Ambition 1.0 TSI

SUMMARY OF THE VEHICLE'S CONDITION

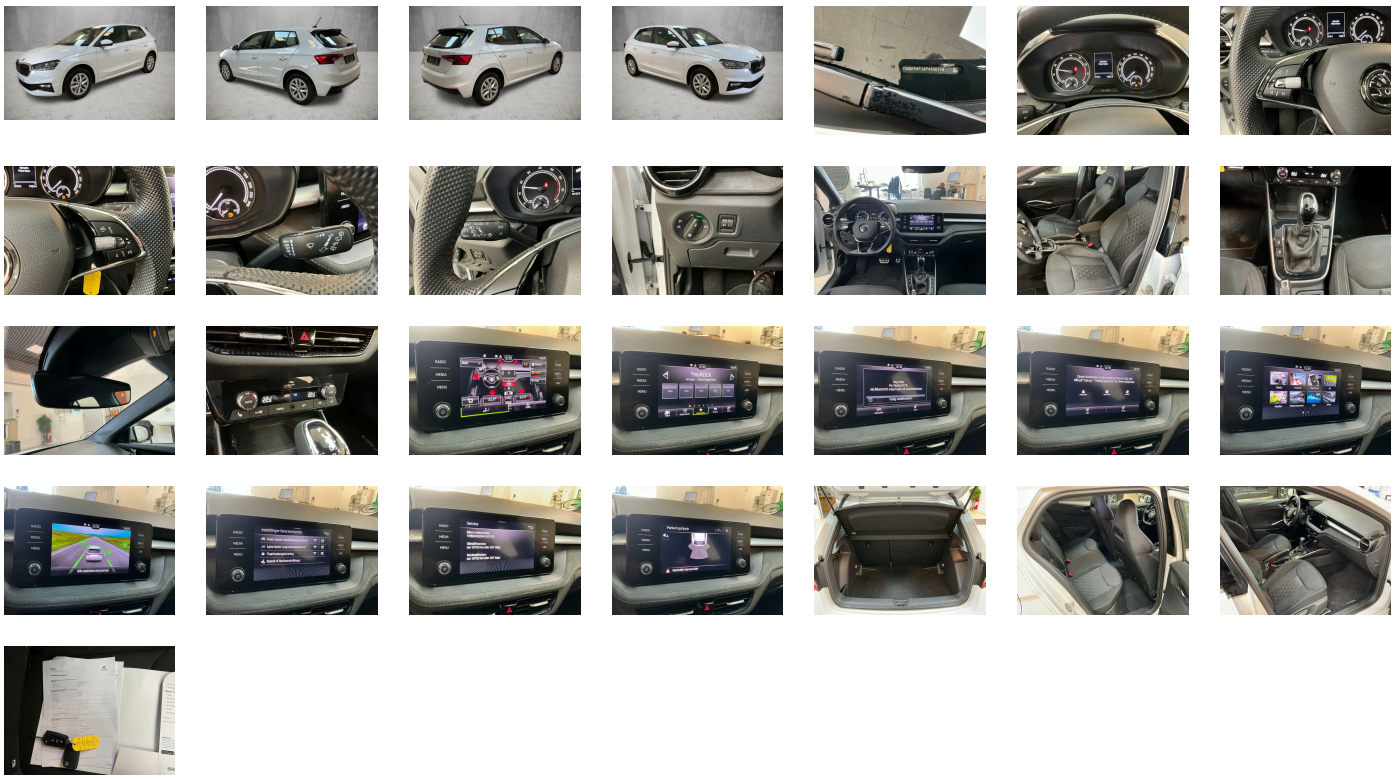
WHEELS

TYPE	SEASON	BRAND	POSITION	RIM	SIZE	TREAD
Fitted	Winter tires		Front Left	Alloy rim	15''	8 mm
Fitted	Winter tires		Rear Right	Alloy rim	15''	8 mm
Fitted	Winter tires		Rear Left	Alloy rim	15''	8 mm
Fitted	Winter tires		Front Right	Alloy rim	15''	8 mm

Legal tire tread (minimum 1.6 mm):

Yes
