VEHICLE DESCRIPTION - Cupra León 2.0 TSI VZ

SUMMARY OF THE VEHICLE'S CONDITION

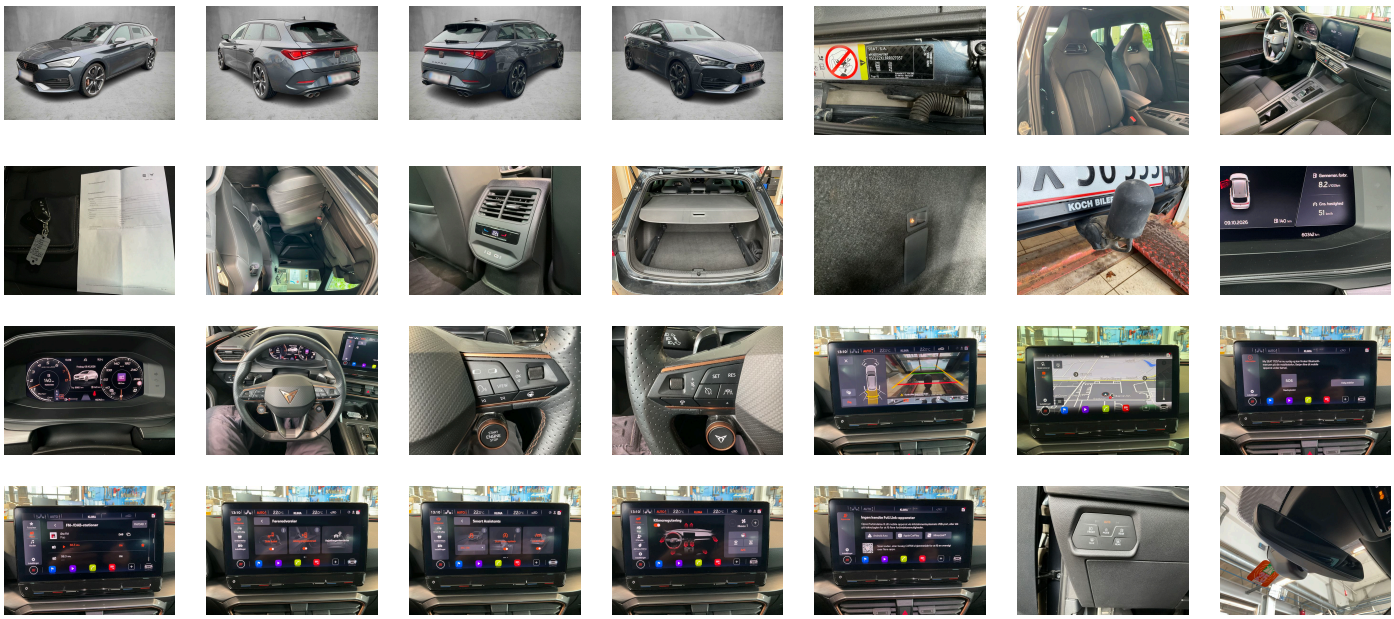
WHEELS

TYPE	SEASON	BRAND	POSITION	RIM	SIZE	TREAD
Fitted	Summer tires		Front Left	Alloy rim	19''	4 mm
Fitted	Summer tires		Rear Right	Alloy rim	19''	4 mm
Fitted	Summer tires		Rear Left	Alloy rim	19''	4 mm
Fitted	Summer tires		Front Right	Alloy rim	19''	4 mm

Legal tire tread (minimum 1.6 mm):
Yes
