VEHICLE DESCRIPTION - VW Polo Life 1.0 TSI

SUMMARY OF THE VEHICLE'S CONDITION

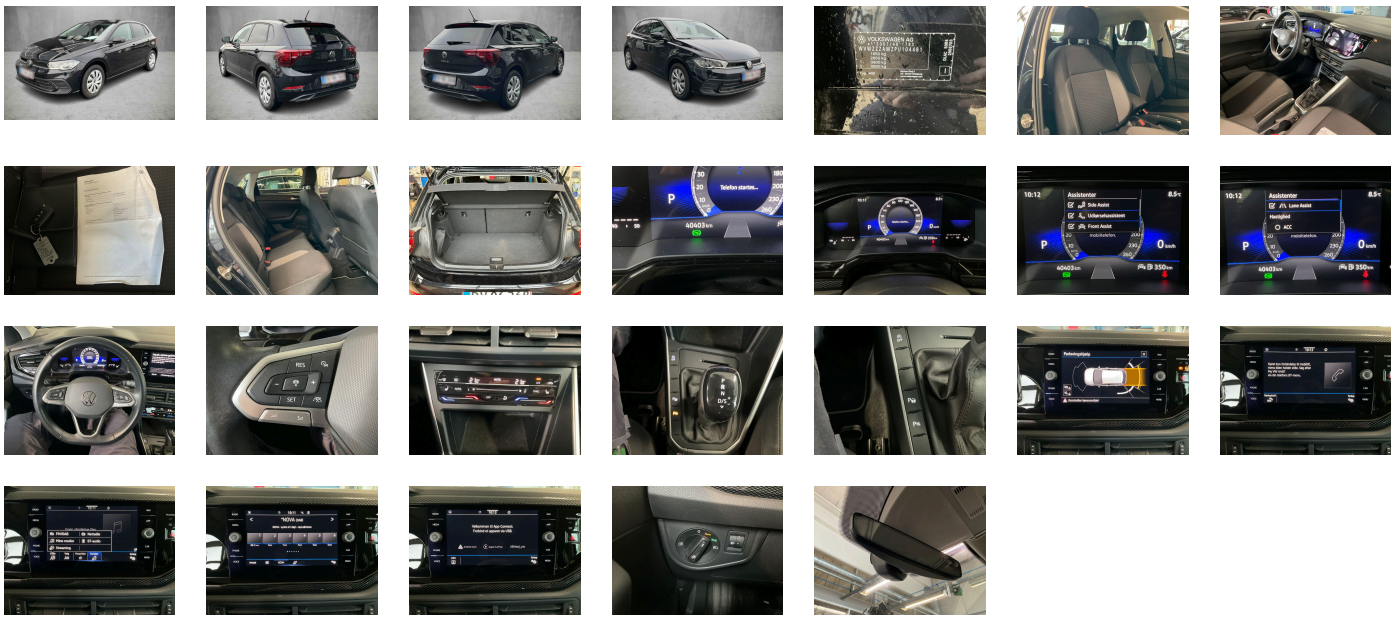
TYPE	SEASON	BRAND	POSITION	RIM	SIZE	TREAD
Fitted	Summer tires		Front Left	Steel rim	15''	5 mm
Fitted	Summer tires		Rear Right	Steel rim	15''	5 mm
Fitted	Summer tires		Rear Left	Steel rim	15''	5 mm
Fitted	Summer tires		Front Right	Steel rim	15''	5 mm

Legal tire tread (minimum 1.6 mm):

Yes
