VEHICLE DESCRIPTION - Škoda Kamiq Monte Carlo 1.0 TSI

SUMMARY OF THE VEHICLE'S CONDITION

OVERVIEW OF DAMAGES AND SHORTAGES

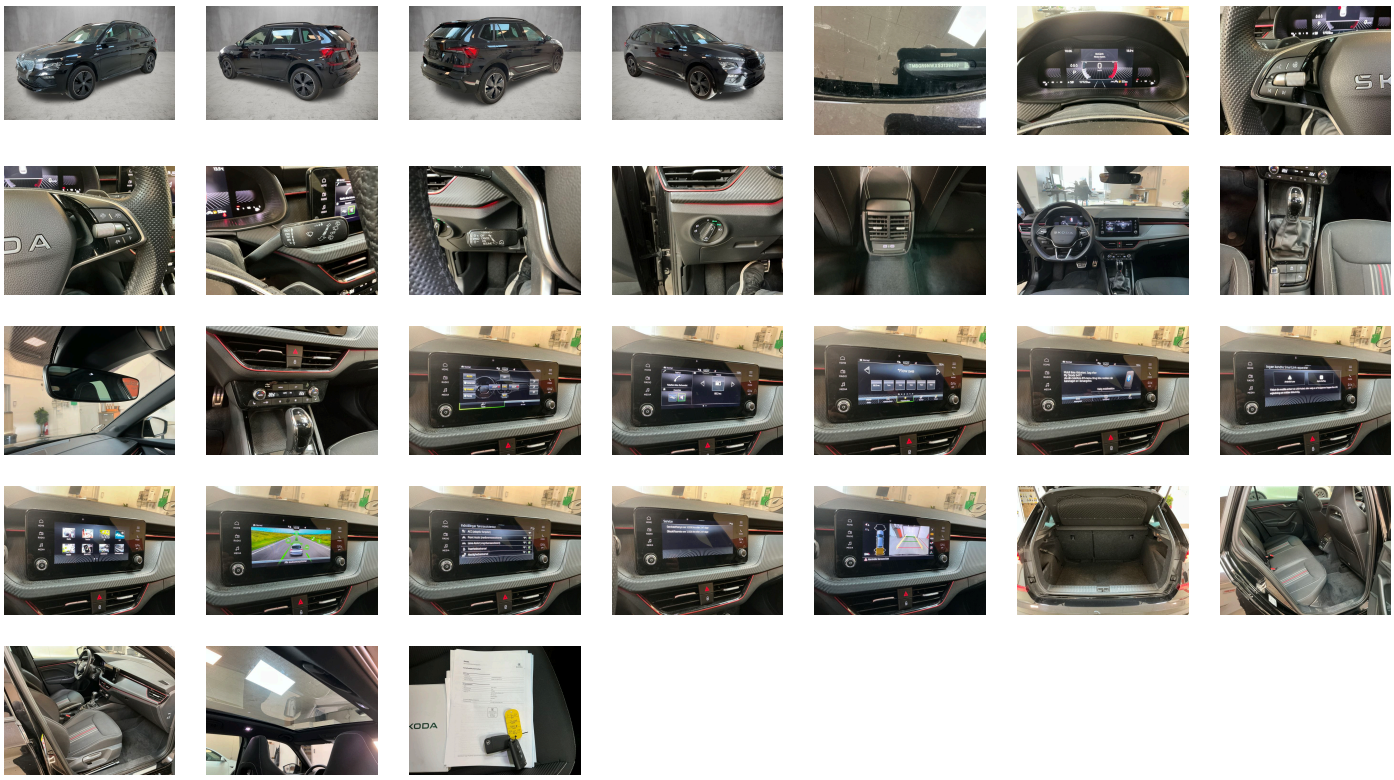
WHEELS

TYPE	SEASON	BRAND	POSITION	RIM	SIZE	TREAD
Fitted	Summer tires		Front Left	Alloy rim	17''	7 mm
Fitted	Summer tires		Rear Right	Alloy rim	17''	7 mm
Fitted	Summer tires		Rear Left	Alloy rim	17''	7 mm
Fitted	Summer tires		Front Right	Alloy rim	17''	7 mm

Legal tire tread (minimum 1.6 mm):

Yes
