CAR VEHICLE DESCRIPTION - Škoda Karoq Style 1.5 TSI

CAR SUMMARY OF THE VEHICLE'S CONDITION**Is the car in a driveable condition:**

OVERVIEW OF DAMAGES AND SHORTAGES

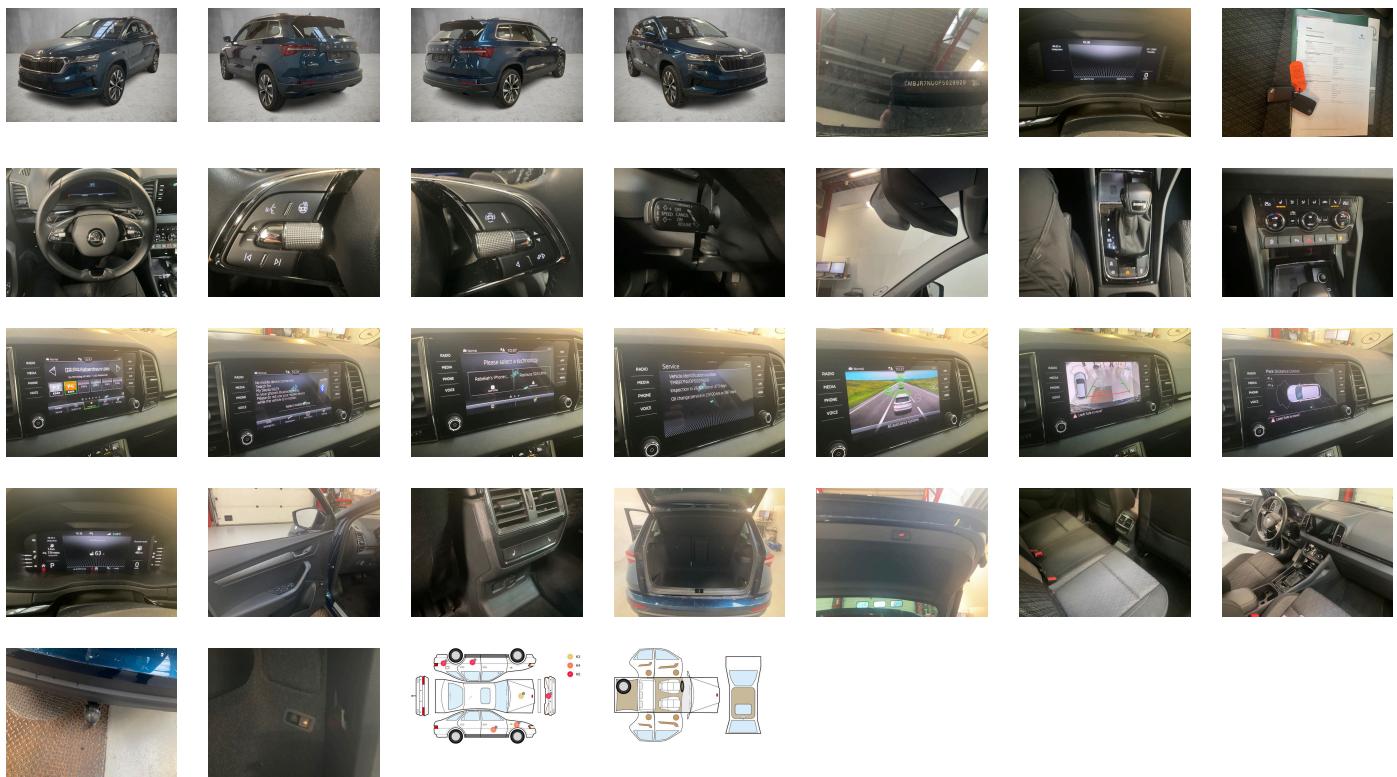
PICTURES

Nº	LOCATION	TYPE	SEVERITY	INSURANCE	NOTES	DAMAGE GROUP
1	L. Rear Quarter Panel, List	Scratch	C5		Reporting needed	Group 1
2	Front Bumper, List	Scratch	C5		Reporting needed	Group 3
3	Front Bumper, Fuel Flap	Scratch	C5		Reporting needed	Group 3
4	L. Rear door, List	Scratch	C5		Reporting needed	Group 1
5	Front Bumper	Scratch	C4		Reporting needed	Group 3
6	R. Front Door	Scratch	C4		Reporting needed	Group 2
7	L. Rear Door	Scratch	C4		Reporting needed	Group 1
8	R. Front Quarter Panel	Scratch	C4		Reporting needed	Group 2
9	Hood	Scratch	C3
