**🚗 VEHICLE DESCRIPTION - Škoda Karoq Style 1.5 TSI**

<b>First registration date:</b>	<b>VIN:</b>
1/2023	TMBJR7NU3P5035580
<b>Colour:</b>	<b>Mileage (km):</b>
Black Metalic Normal gloss	63.258
<b>Gear:</b>	<b>Fuel type:</b>
Automatic (7 Gears)	Gasoline
<b>Body type:</b>	<b>Number of doors:</b>
SUV	5
<b>Drive type:</b>	<b>Model year:</b>
FWD	2022
<b>Engine power:</b>	<b>Number of seats:</b>
110 kW	5
<b>Engine size (cc)</b>	<b>Interior:</b>
1498

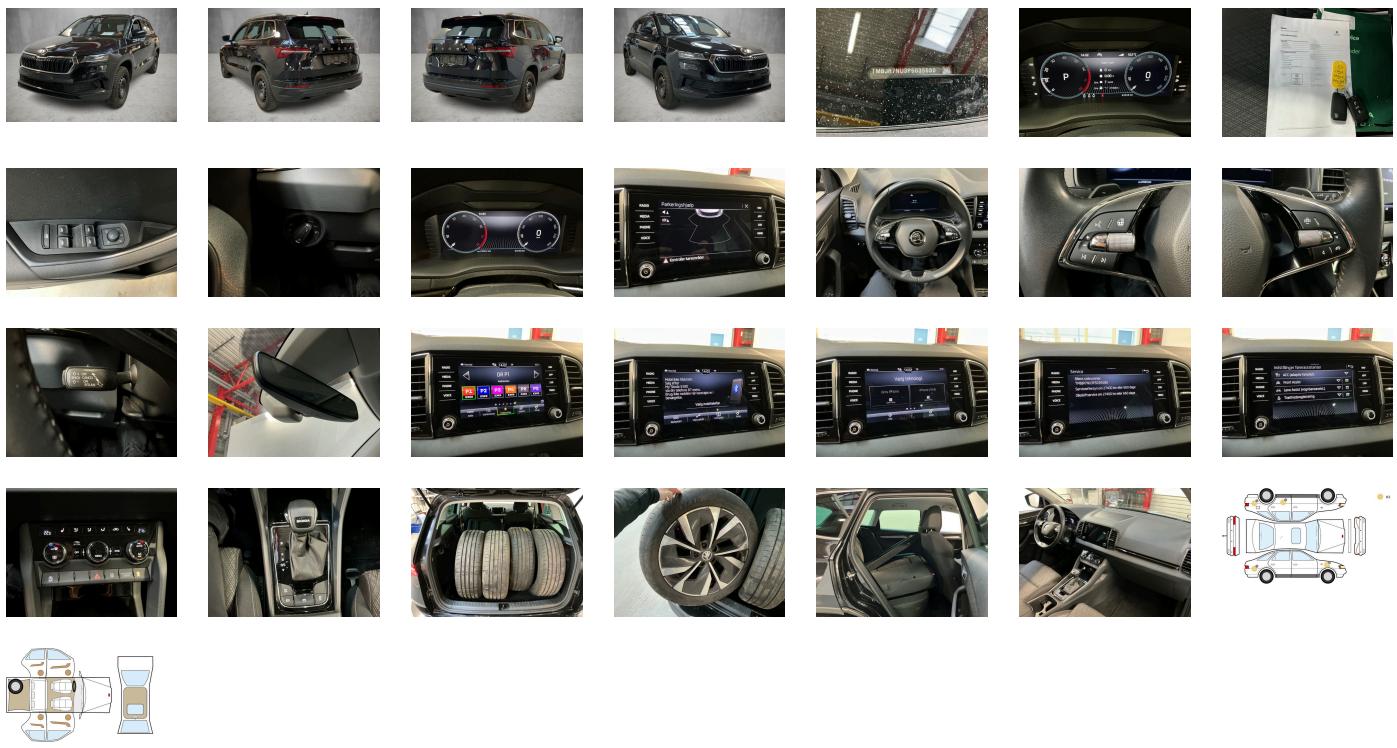
**PICTURES**

Nº	LOCATION	TYPE	SEVERITY	INSURANCE	NOTES	DAMAGE GROUP
1	L. Rear Door	Dent	C3			
2	R. Front Quarter Panel	Dent	C3			
3	R. Rear Quarter Panel	Dent	C3			
4	L. Rear Quarter Panel	Scratch	C3

C0 = No damage / C1 = Simple preparation / C2 = Minor preparation needed / C3 = Can be smart repaired / C4 = Repair/spray paint / C5 = Need replacement
