🚗 VEHICLE DESCRIPTION - Seat Ibiza Dynamic FR 1.0 MPI

OVERVIEW OF DAMAGES AND SHORTAGES

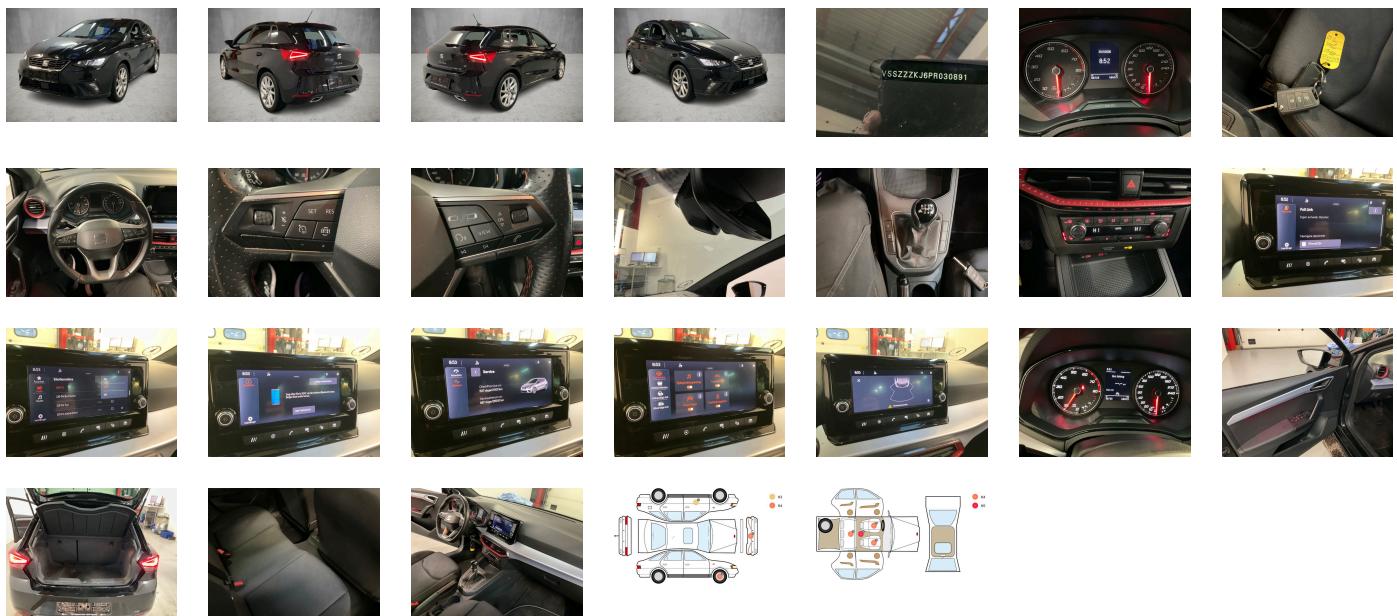
PICTURES

| Nº | LOCATION | TYPE | SEVERITY | INSURANCE | NOTES | DAMAGE GROUP |
|---|---|---|---|---|---|---|
| 1 | Floor Cover | Hole | C5 | | Reporting needed Bund beklædning | |
| 2 | R. Front Rim | Scratch | C4 | | Reporting needed | |
| 3 | Front Bumper | Scratch | C4 | | Reporting needed | |
| 4 | Rear Seat | Discoloration | C4 | | Reporting needed | |
| 5 | Passenger Seat | Discoloration | C4 | | Reporting needed | |
| 6 | Drivers Seat | Wear and tear | C4 | | Reporting needed | |
| 7 | L. Front door | Scratch | C3 | | | |
