CAR VEHICLE DESCRIPTION - Škoda Kamiq Life 1.0 TSI

PICTURES

OVERVIEW OF DAMAGES AND SHORTAGES

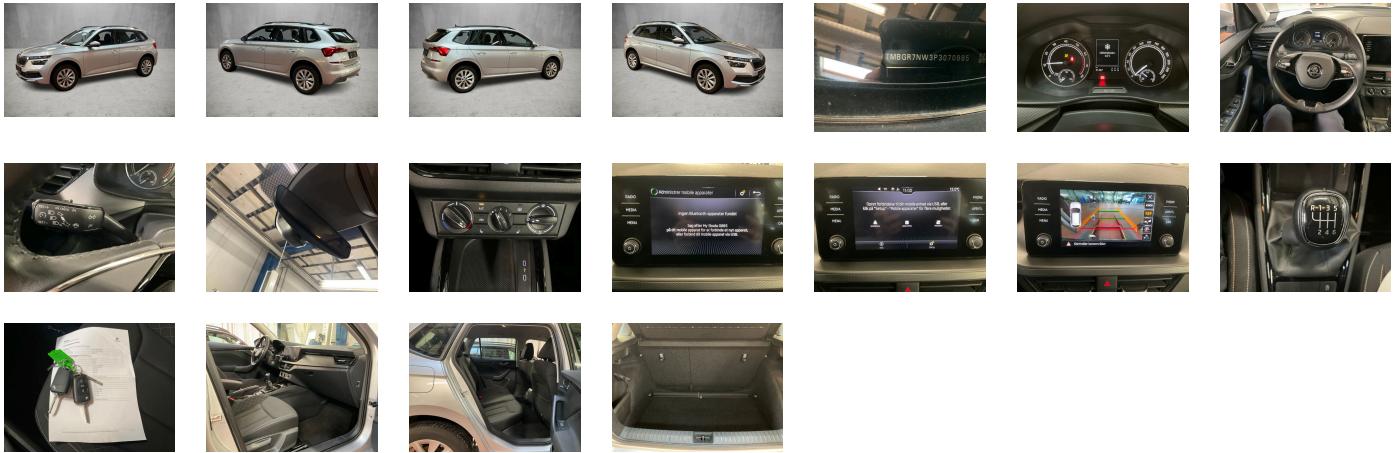
Nº	LOCATION	TYPE	SEVERITY	INSURANCE	NOTES	DAMAGE GROUP
1	Front Bumper	Scratch	C4		Reporting done	
2	R. Front Light	Scratch	C3			
3	Hood	Scratch	C3			
4	Rear Bumper	Scratch	C3			
5	Front Bumper, Spoiler	Scratch	C3

C0 = No damage / C1 = Simple preparation / C2 = Minor preparation needed / C3 = Can be smart repaired / C4 = Repair/spray paint / C5 = Need replacement
