VEHICLE DESCRIPTION - Škoda Scala Blackline 1.0 TSI

Inspection date:
19-11-2025

SUMMARY OF THE VEHICLE'S CONDITION

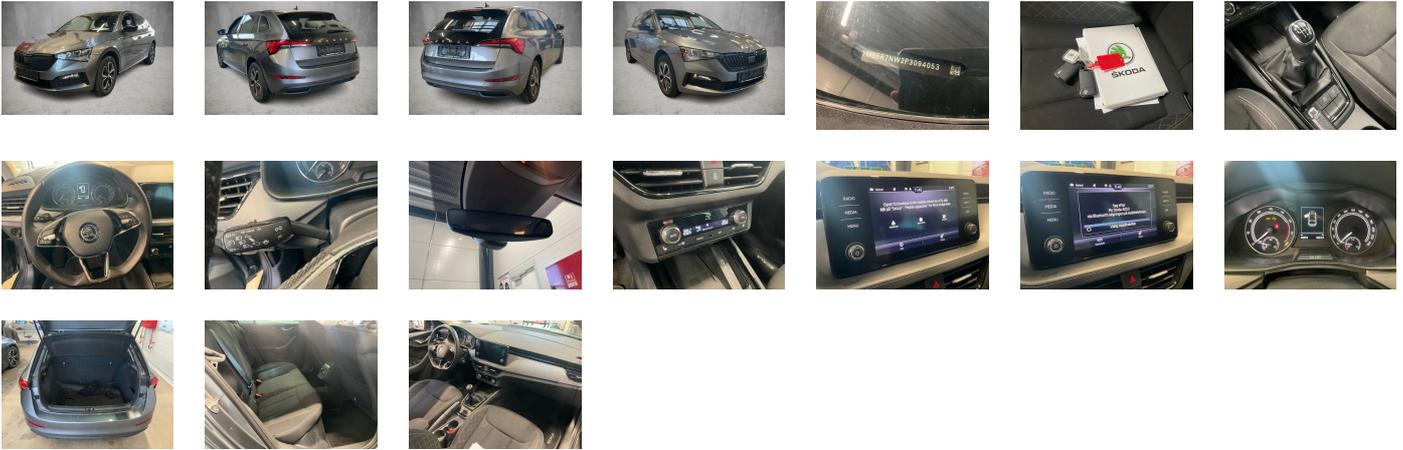
PICTURES

N°	LOCATION	TYPE	SEVERITY	INSURANCE	NOTES	DAMAGE GROUP
1	Rear Bumper	Scratch	C4		Reporting needed

2	Front Bumper	Scratch	C4		Reporting needed

3	L. Rear Quarter Panel	Scratch	C3			
4	R. Front Rim	Scratch	C3			
5	R. Rear Rim	Scratch	C3			
6	L. Rear Rim	Scratch	C3			
7	L. Front Rim	Scratch	C3
