VEHICLE DESCRIPTION - Škoda Kamiq Life 1.0 TSI

VIN:
TMBGR7NW9P3113688

Inspection date:
24-04-2026

SUMMARY OF THE VEHICLE'S CONDITION

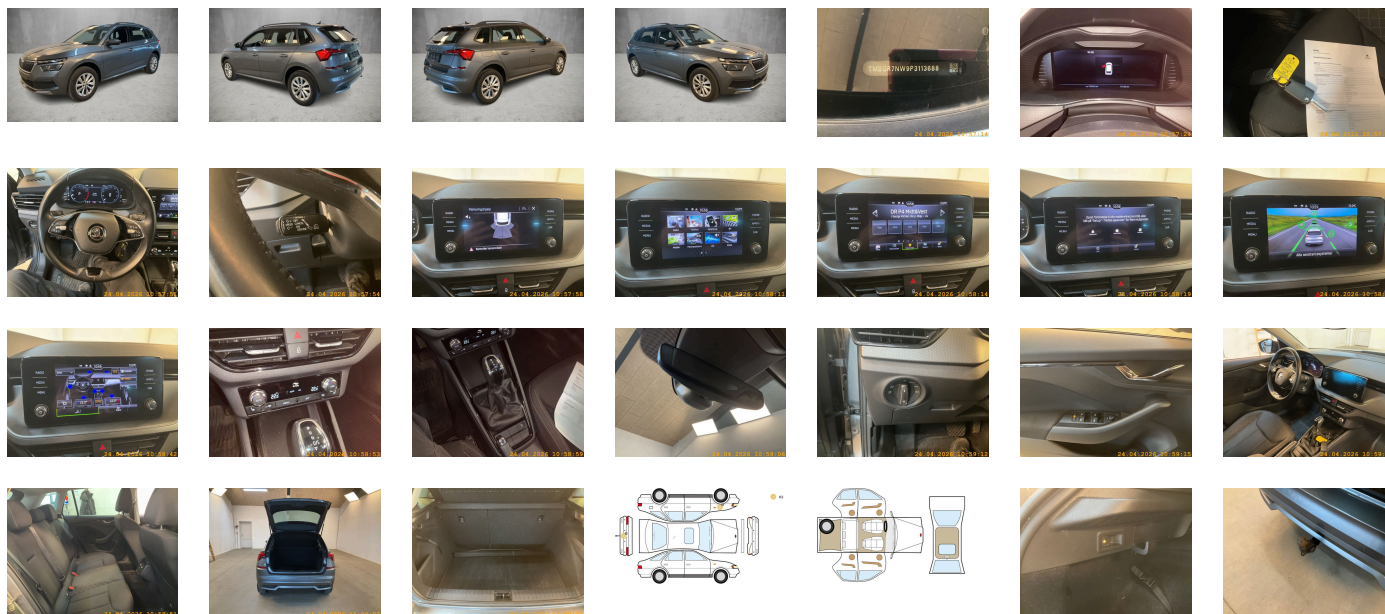
PICTURES

N°	LOCATION	TYPE	SEVERITY	INSURANCE	NOTES	DAMAGE GROUP
1	Rear Bumper

Scratch

C3			
2	L. Front Quarter Panel

C3
