VEHICLE DESCRIPTION - Škoda Kamiq Life 1.0 TSI

SUMMARY OF THE VEHICLE'S CONDITION

## OVERVIEW OF DAMAGES AND SHORTAGES

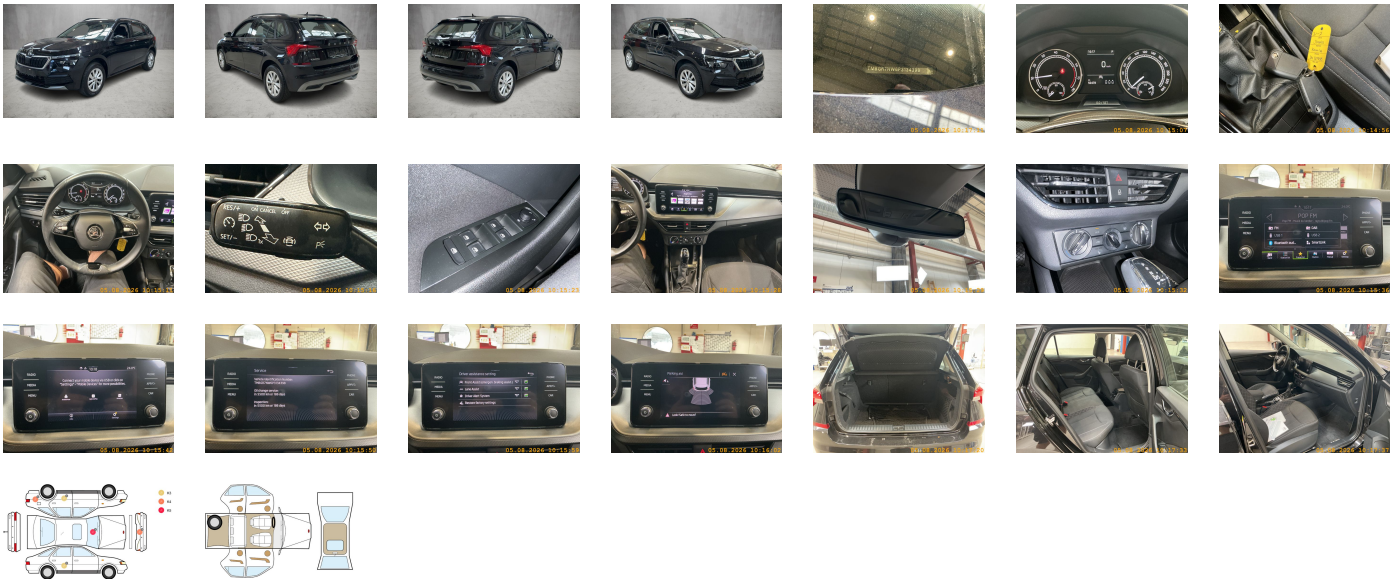
## PICTURES

| N° | LOCATION | TYPE | SEVERITY | INSURANCE | NOTES | DAMAGE GROUP |
|---|---|---|---|---|---|---|
| 1 | Front Windscreen | Stone Chips | C5 | Reporting needed | | |
| 2 | Front Bumper | Scratch | C4 | Reporting done | | |
| 3 | L. Rear Quarter Panel | Dent | C4 | Reporting done | | |
| 4 | L. Rear Door | Scratch | C3 | | | |
| 5 | R. Rear Door | Dent | C3 | | | |
