**CAR VEHICLE DESCRIPTION - Škoda Kamiq Black Line 1.0 TSI**

TMBGR7NW5P3166081

26-11-2025

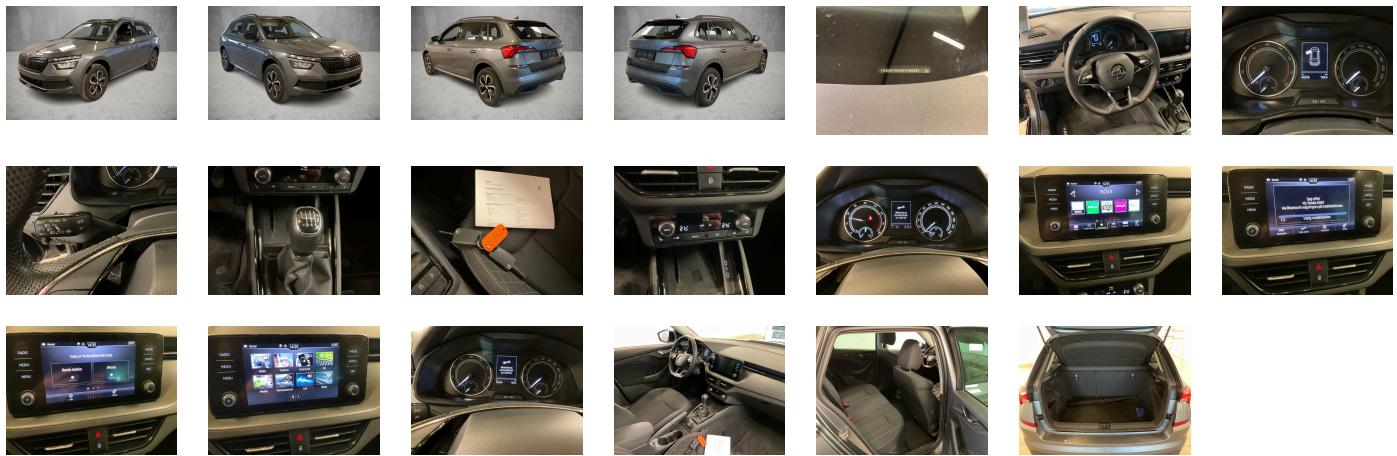
**PICTURES**

Nº	LOCATION	TYPE	SEVERITY	INSURANCE	NOTES	DAMAGE GROUP
1	Front Bumper, Spoiler	Scratch	C5		Reporting needed	
2	Front Bumper	Scratch	C4		Reporting needed	
3	Hood	Dent	C3			
4	L. Rear Quarter Panel	Dent	C3			
5	Rear Bumper	Scratch	C3
