VEHICLE DESCRIPTION - Škoda Kamiq Blackline 1.0 TSI

SUMMARY OF THE VEHICLE'S CONDITION

## OVERVIEW OF DAMAGES AND SHORTAGES

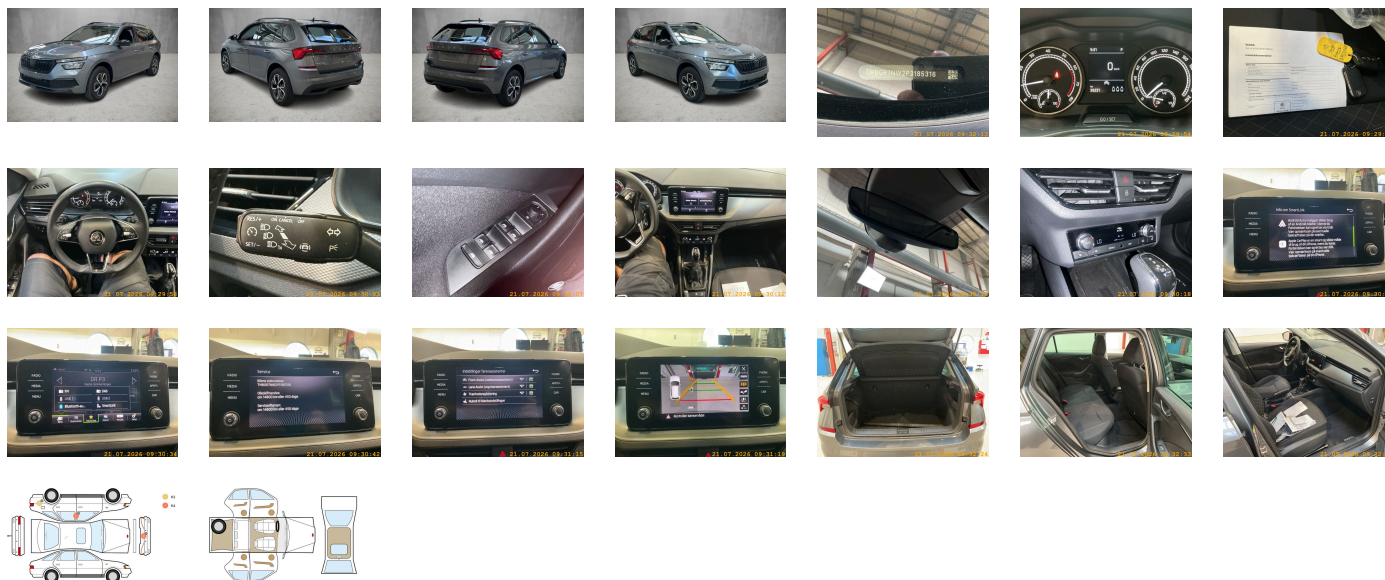
## PICTURES

| N° | LOCATION | TYPE | SEVERITY | INSURANCE | NOTES | DAMAGE GROUP |
|---|---|---|---|---|---|---|
| 1 | Front Bumper | Scratch | C4 | | Reporting needed | |
| 2 | L. Roof Pillar, C-Pillar | Scratch | C4 | | Reporting needed | |
| 3 | L. Rear Quarter Panel | Dent | C3 | | | |
