VEHICLE DESCRIPTION - Škoda Kamiq Tour De France 1.0 TSI

SUMMARY OF THE VEHICLE'S CONDITION

## OVERVIEW OF DAMAGES AND SHORTAGES

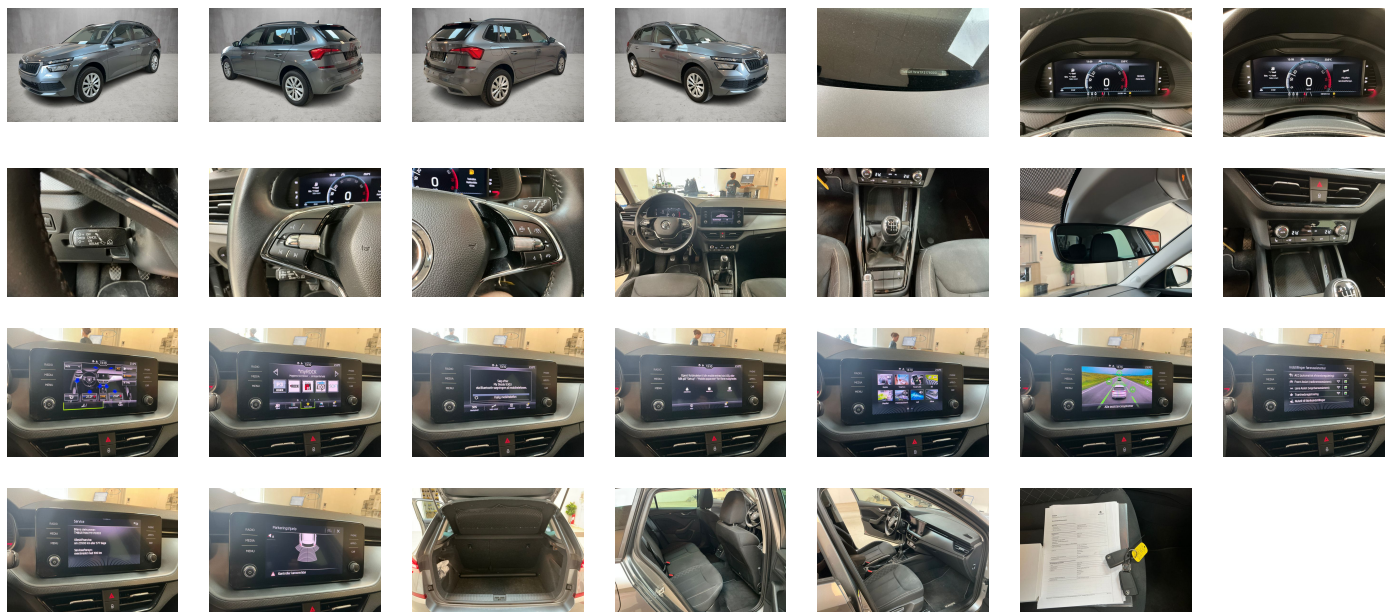
## PICTURES

| N° | LOCATION | TYPE | SEVERITY | INSURANCE | NOTES | DAMAGE GROUP |
|---|---|---|---|---|---|---|
| 1 | Front Windscreen | Stone Chips | C5 | Reporting needed | | |
| 2 | L. Rocker Panel, Inside | Scratch | C3 | | | |
| 3 | Rear Bumper | Scratch | C3 | | | |
| 4 | Front Bumper | Scratch | C3 | | | |
| 5 | L. Front door | Paint Flaking | C3 | | | |
| 6 | L. Rear Door | Scratch | C3 | | | |
