VEHICLE DESCRIPTION - Škoda Scala Tour De France 1.0 TSI

SUMMARY OF THE VEHICLE'S CONDITION

OVERVIEW OF DAMAGES AND SHORTAGES

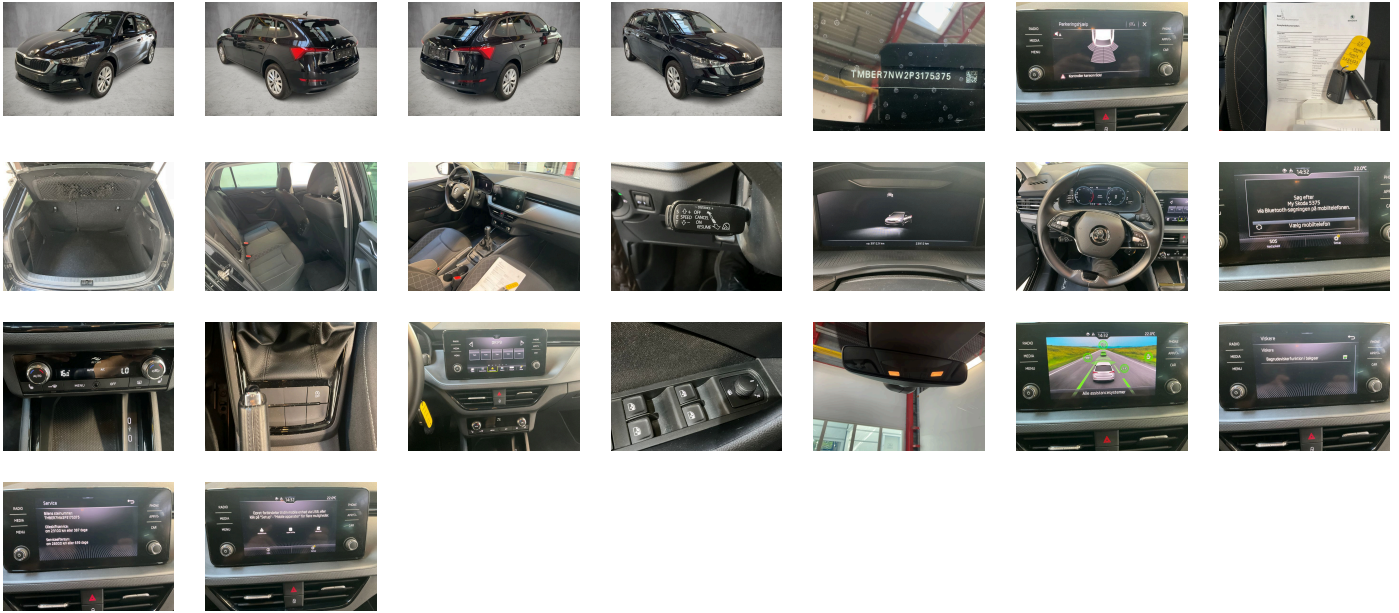
PICTURES

N°	LOCATION	TYPE	SEVERITY	INSURANCE	NOTES	DAMAGE GROUP
1	Front Bumper, List	Cracked	C5		Reporting needed	Group 1

2	R. Front Quarter Panel	Scratch	C4		Reporting needed	Group 1

3	Front Bumper	Scratch	C4		Reporting needed	Group 1
