VEHICLE DESCRIPTION - Audi Q2 Prestige 1.0 30 TFSI

SUMMARY OF THE VEHICLE'S CONDITION

## OVERVIEW OF DAMAGES AND SHORTAGES

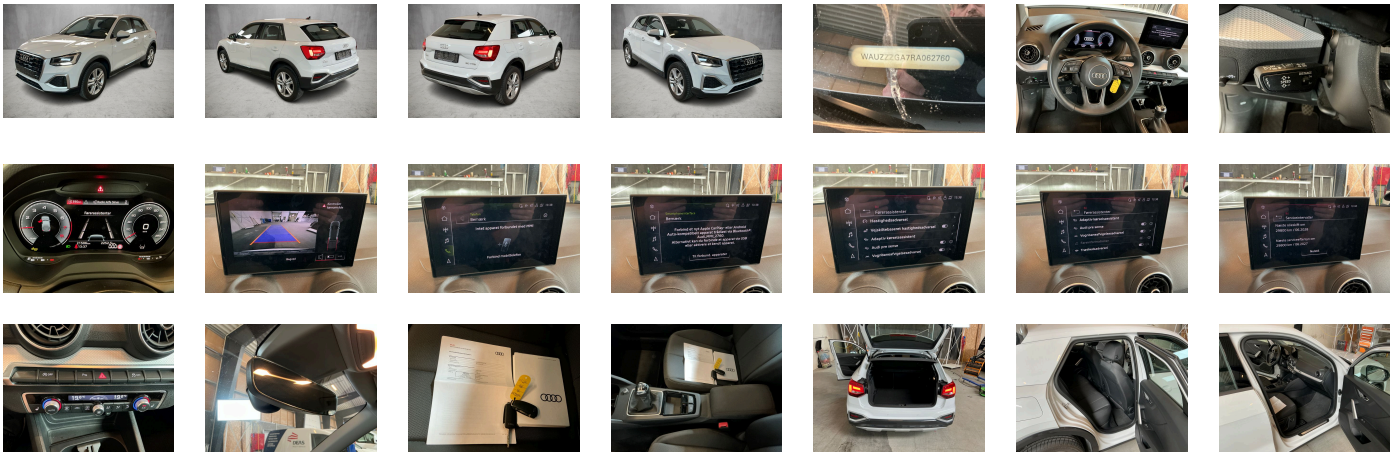
## PICTURES

| N° | LOCATION | TYPE | SEVERITY | INSURANCE | NOTES | DAMAGE GROUP |
|---|---|---|---|---|---|---|
| 1 | R. Front Rim | Scratch | C4 | Reporting needed | | |
| 2 | L. Rocker Panel, Inside | Scratch | C3 | | | |
| 3 | Front Bumper, Fuel Flap | Scratch | C3 | | | |
| 4 | R. Rocker Panel, Inside | Dent | C3 | | | |
