VEHICLE DESCRIPTION - Škoda Kamiq Selection 1.0 TSI

SUMMARY OF THE VEHICLE'S CONDITION

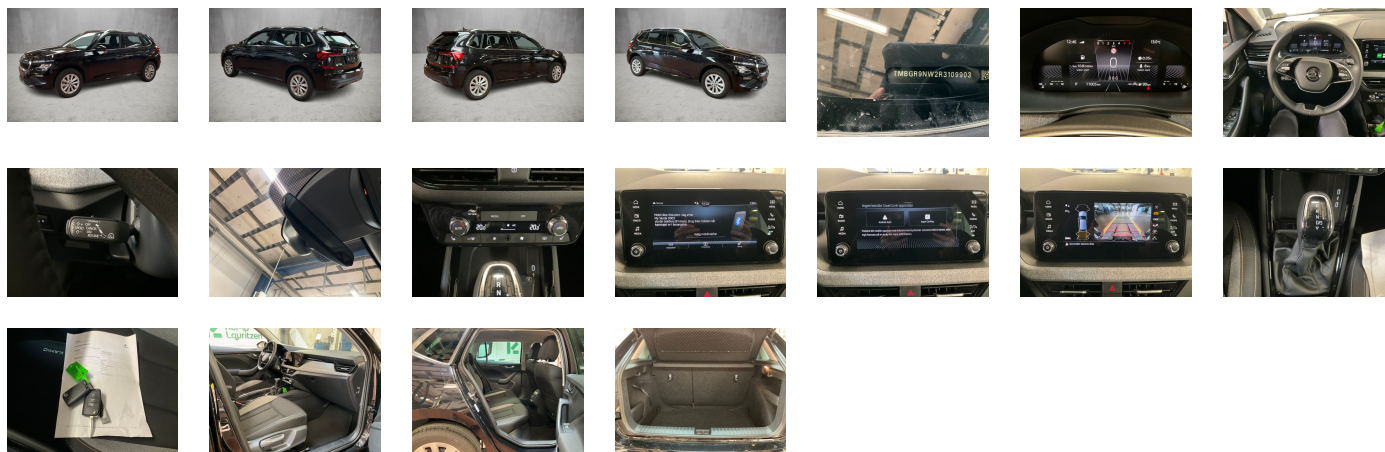
## PICTURES

| N° | LOCATION | TYPE | SEVERITY | INSURANCE | NOTES | DAMAGE GROUP |
|---|---|---|---|---|---|---|
| 1 | L. Rocker Panel | Dent | C4 | Reporting done | | |
| 2 | R. Rear Quarter Panel | Scratch | C3 | | | |
| 3 | Rear Bumper | Scratch | C3 | | | |
