VEHICLE DESCRIPTION - Škoda Karoq Selection 1.5 TSI

SUMMARY OF THE VEHICLE'S CONDITION

OVERVIEW OF DAMAGES AND SHORTAGES

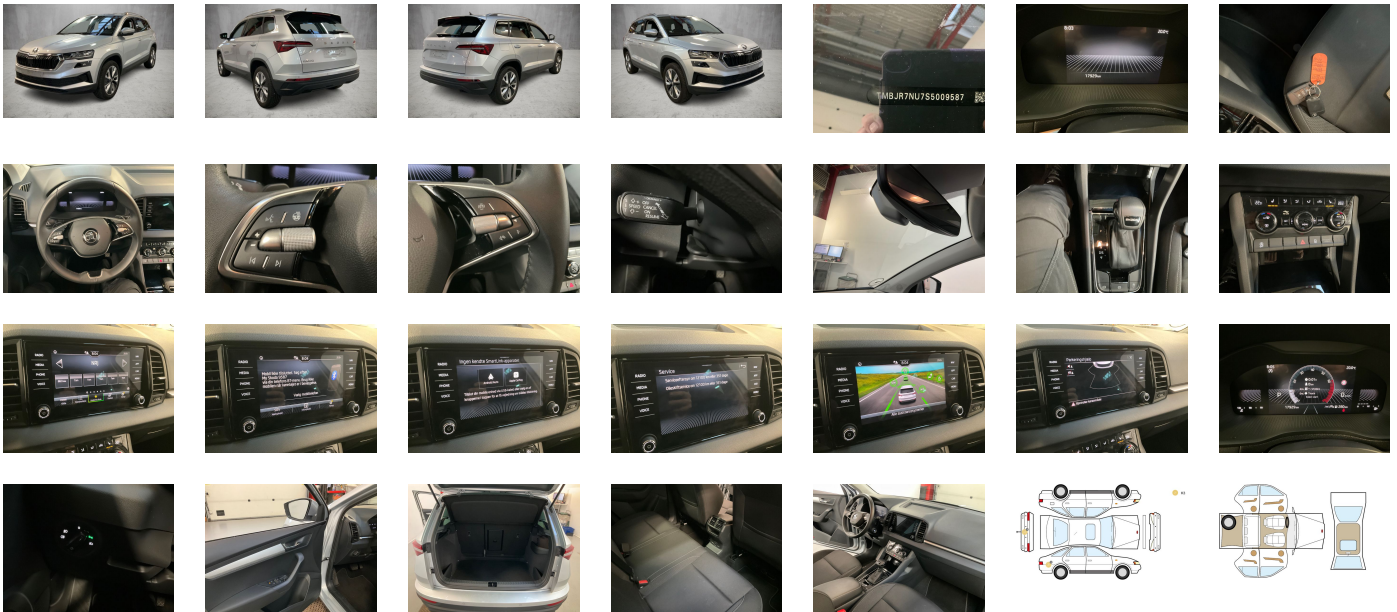
## PICTURES

| N° | LOCATION | TYPE | SEVERITY | INSURANCE | NOTES | DAMAGE GROUP |
|---|---|---|---|---|---|---|
| 1 | R. Rear Quarter Panel | Dent | C3 | | | |
| 2 | Rear Bumper | Scratch | C3 | | | |
