🚗 VEHICLE DESCRIPTION - Seat Ibiza FR 1.0 TSI

🚗 SUMMARY OF THE VEHICLE'S CONDITION

OVERVIEW OF DAMAGES AND SHORTAGES

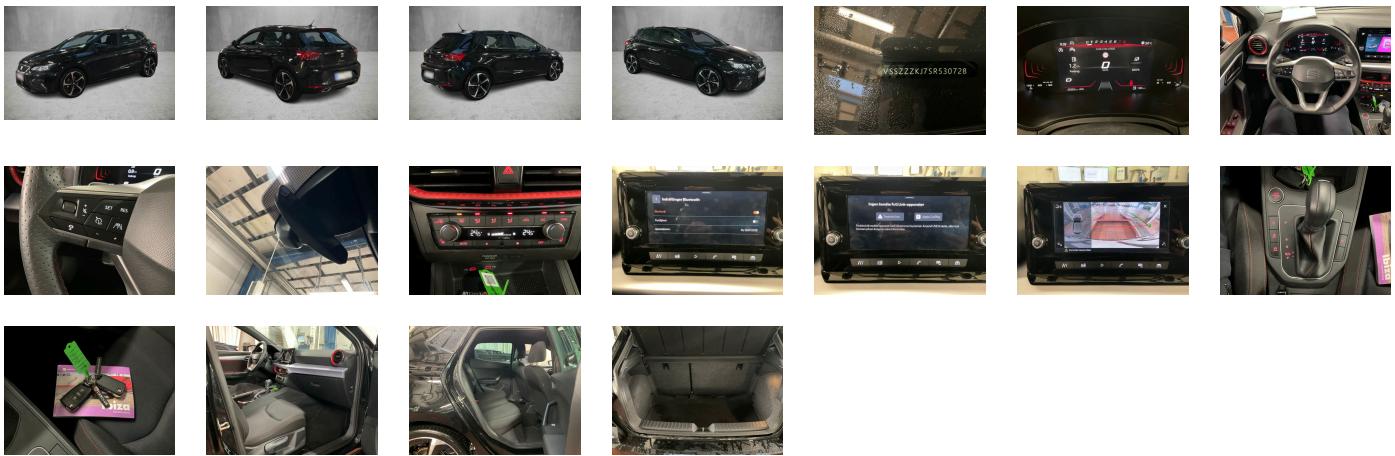
PICTURES

Nº	LOCATION	TYPE	SEVERITY	INSURANCE	NOTES	DAMAGE GROUP
1	R. Front Rim	Scratch	C5		Reporting needed	
2	R. Mirror, Casing	Scratch	C5		Reporting needed	
3	Rear Bumper	Dent	C4		Reporting needed	Group 1
4	Rear Bumper, SpoilerDent		C4		Reporting needed	Group 1
5	Front Bumper	Dent	C4		Reporting needed	
6	L. Rear Door	Dent	C3			
7	R. Rear Door	Dent	C3
