VEHICLE DESCRIPTION - Seat Ibiza FR 1.0 TSI

SUMMARY OF THE VEHICLE'S CONDITION

OVERVIEW OF DAMAGES AND SHORTAGES

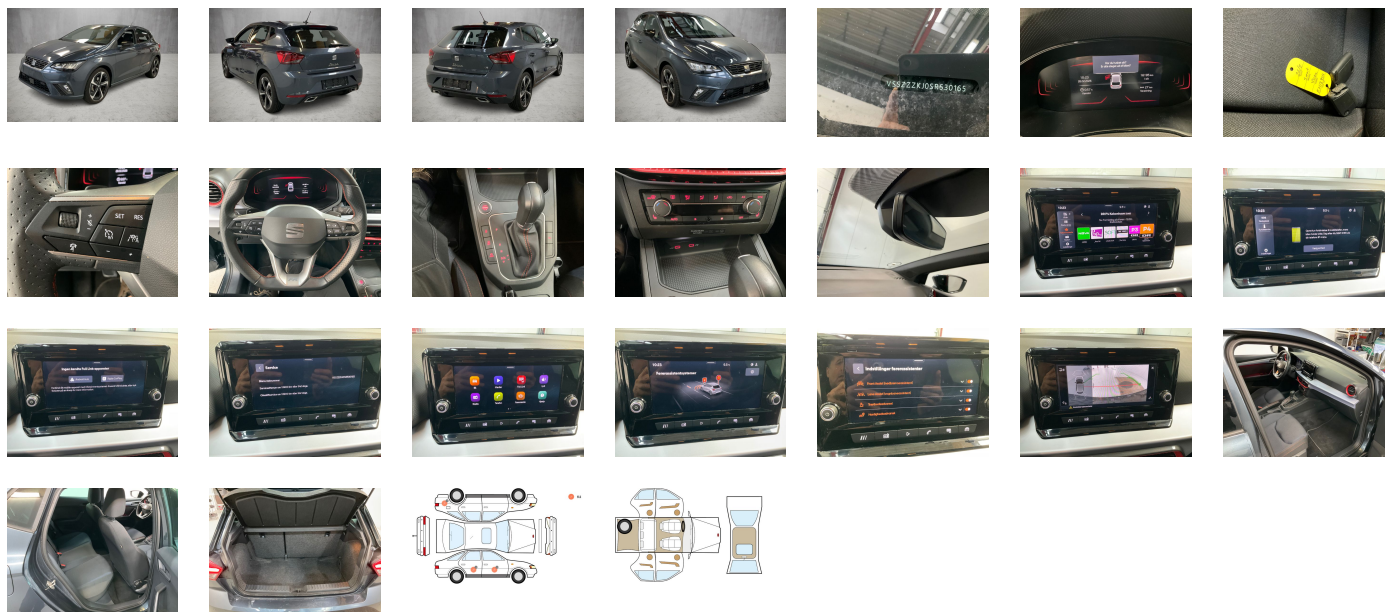
## PICTURES

| N° | LOCATION | TYPE | SEVERITY | INSURANCE | NOTES | DAMAGE GROUP |
|---|---|---|---|---|---|---|
| 1 | L. Rear Quarter Panel | Dent | C4 | | Reporting needed | |
| 2 | R. Front Door | Dent | C4 | | Reporting needed | |
| 3 | R. Rear Door | Dent | C4 | | Reporting needed | |
