VEHICLE DESCRIPTION - Škoda Karoq Selection 1.5 TSI

Inspection date:
31-03-2026

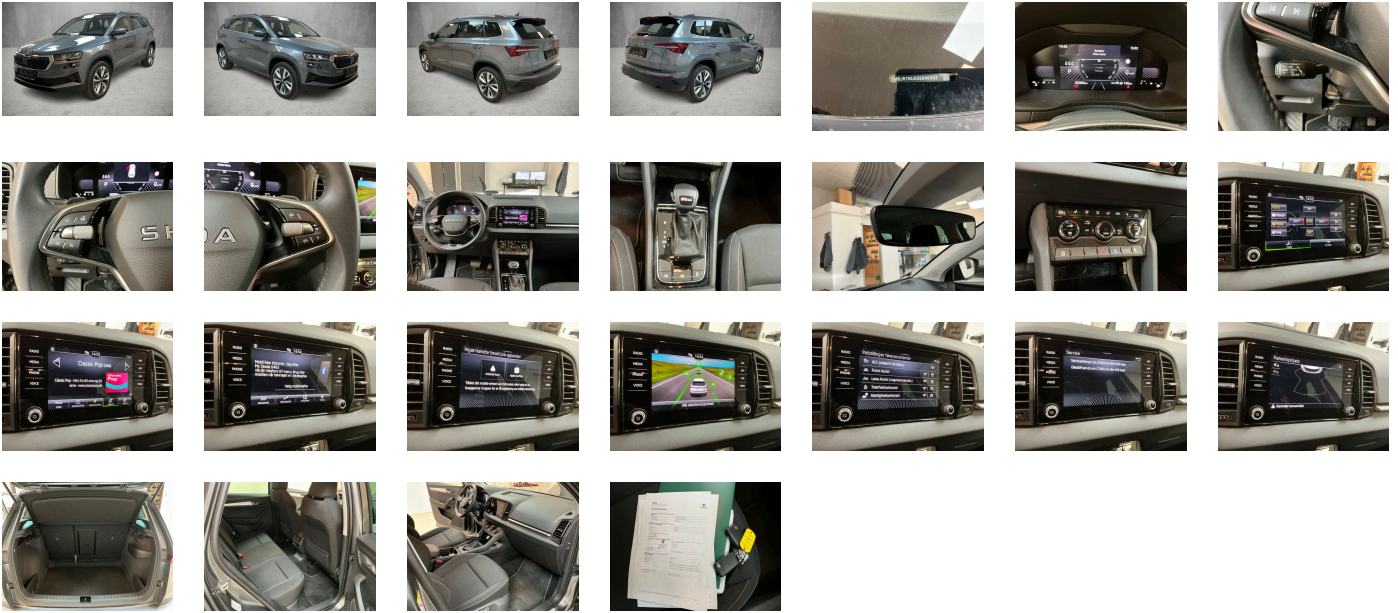
PICTURES

N°	LOCATION	TYPE	SEVERITY	INSURANCE	NOTES	DAMAGE GROUP
1	R. Rear Rim	Scratch	C4		Reporting needed

2	Instrument panel, Center Console	Hole	C4		Reporting needed Armlæn

3	Front Bumper	Stone Chips	C3

4	Rear Bumper	Scratch	C3
