VEHICLE DESCRIPTION - Škoda Kamiq Selection 1.0 TSI

Inspection date:
27-03-2026

SUMMARY OF THE VEHICLE'S CONDITION

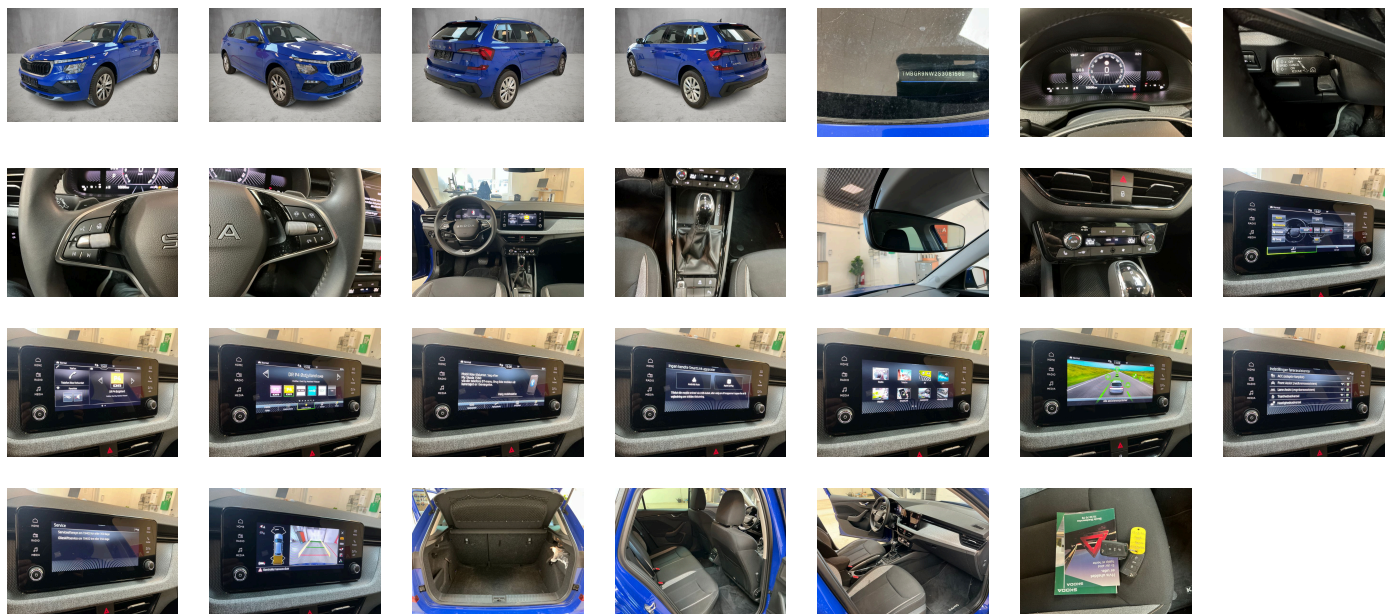
PICTURES

N°	LOCATION	TYPE	SEVERITY	INSURANCE	NOTES	DAMAGE GROUP
1	Rear R. Door Trim, Handle	Scratch	C5		Reporting needed

2	Cabin	Cleaning	C4		Reporting needed

3	Passenger Seat, Floor	Discoloration	C4		Reporting needed

4	Rear Bumper	Scratch	C3

5	L. Mirror, Casing	Scratch	C3
