VEHICLE DESCRIPTION - Škoda Kamiq Selection 1.0 TSI

Inspection date:
08-06-2026

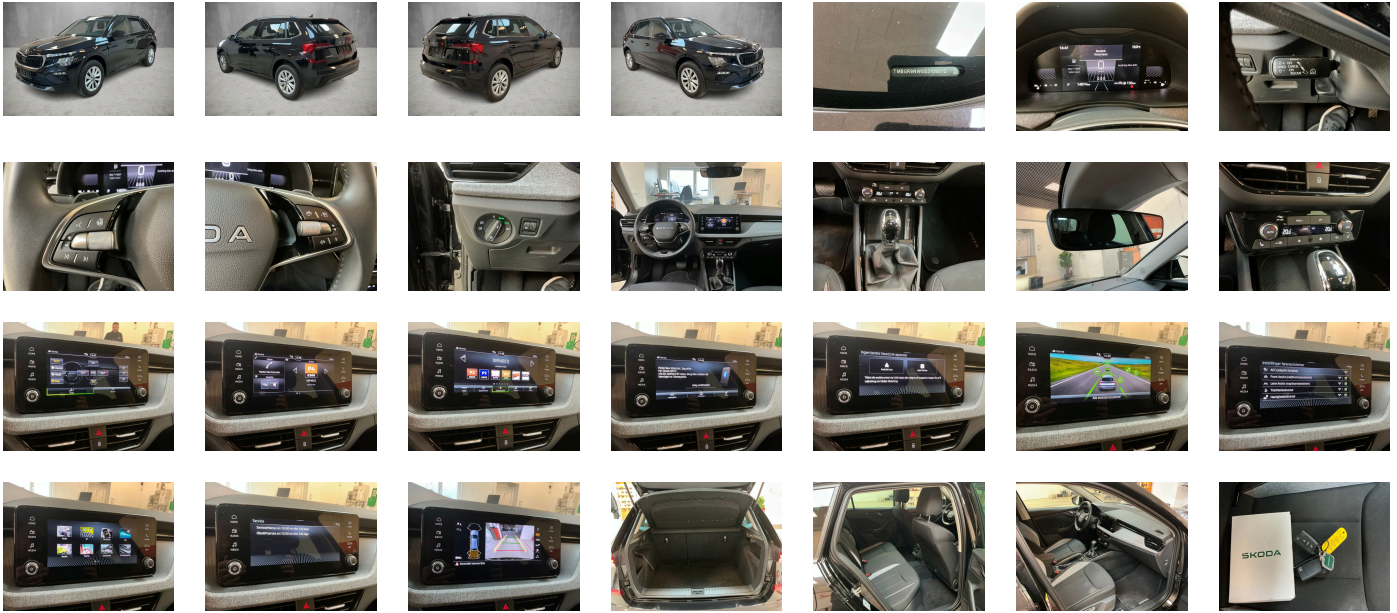
PICTURES

N°	LOCATION	TYPE	SEVERITY	INSURANCE	NOTES	DAMAGE GROUP
1	R. Front Quarter Panel	Dent	C4		Reporting needed

2	L. Rear door, List	Scratch	C3

3	Rear Hood	Scratch	C3

4	Front Bumper	Scratch	C3

5	R. Front Door	Scratch	C3

6	Passenger Seat	Discoloration	C3

7	L. Rocker Panel, Inside	Scratch	C3

8	R. Rear Quarter Panel	Scratch	C3
