**VEHICLE DESCRIPTION - Škoda Scala Selection 1.0 TSI**

**Inspection date:**  
09-06-2026

## OVERVIEW OF DAMAGES AND SHORTAGES

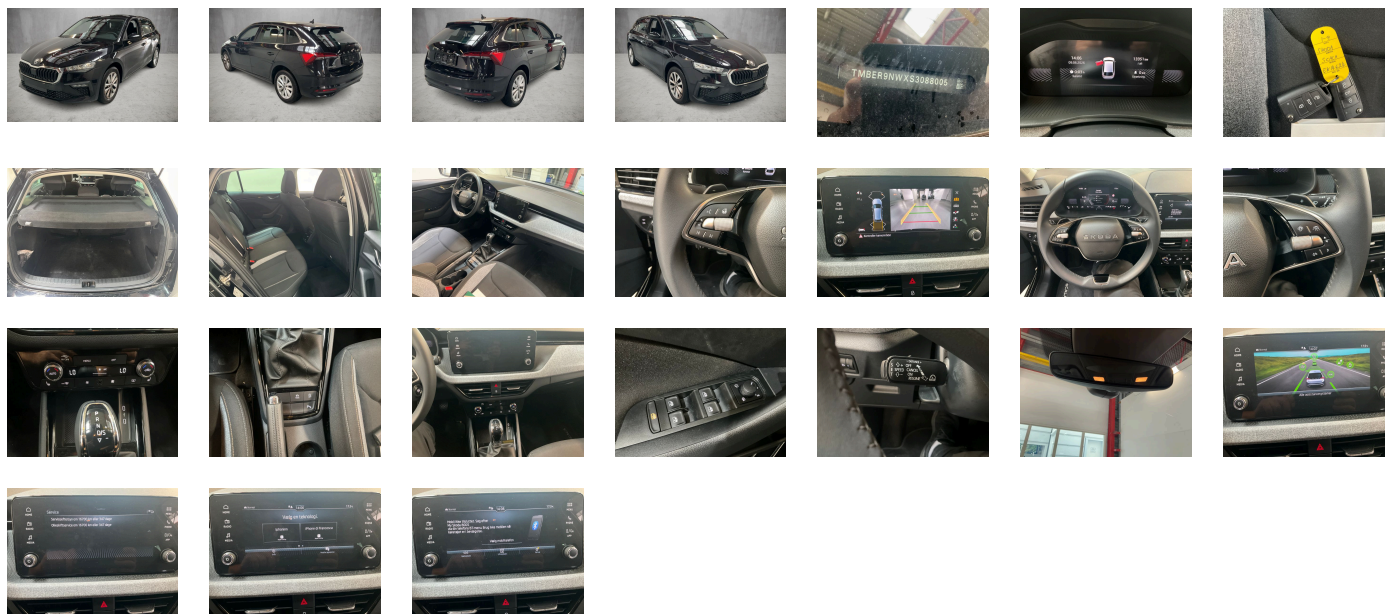
**PICTURES**

N°	LOCATION	TYPE	SEVERITY	INSURANCE	NOTES	DAMAGE GROUP
1	L. Rear Quarter Panel	Dent	C4		Reporting needed

2	R. Rear Door	Scratch	C3
