VEHICLE DESCRIPTION - Škoda Karoq Selection 1.5 TSI

VIN:
TMBJR7NU3S5056759

Inspection date:
26-06-2026

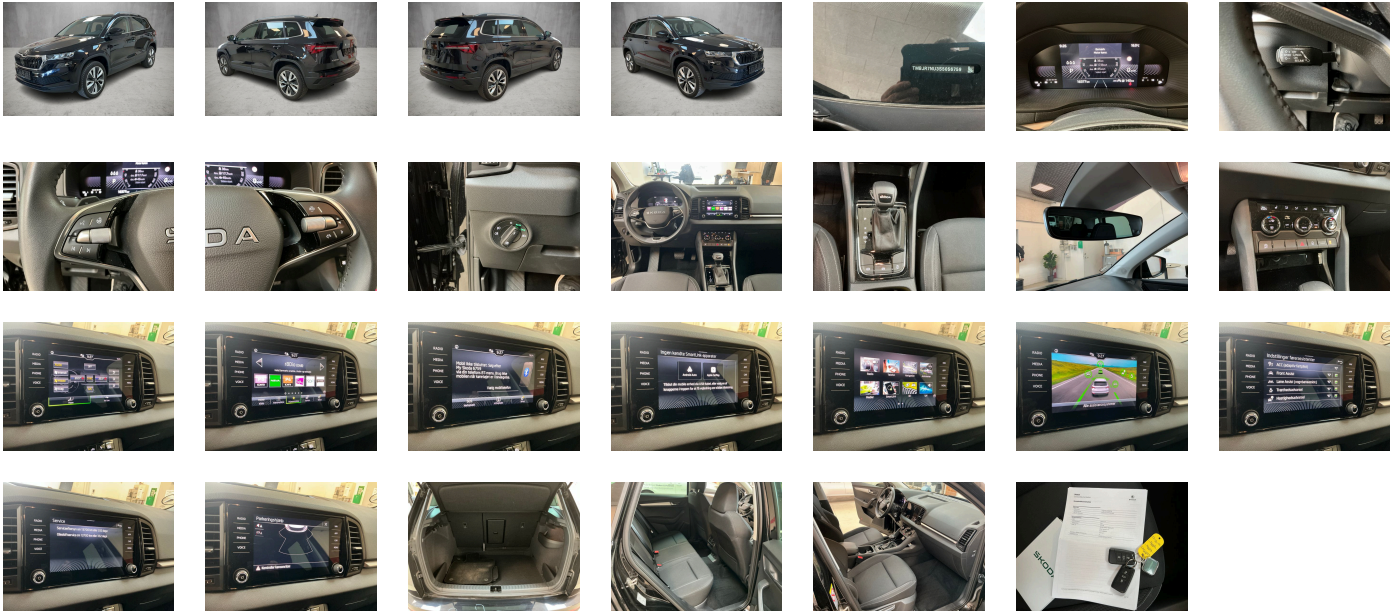
PICTURES

N°	LOCATION	TYPE	SEVERITY	INSURANCE	NOTES	DAMAGE GROUP
1	R. Front Rim

Scratch	C4		Reporting needed	
2	L. Rear Door

Scratch	C3			
3	Rear Hood

Scratch	C3			
4	Rear Bumper

Scratch	C3			
5	R. Rear Door

Scratch	C3			
6	R. Rear Door, List

Discoloration	C3			
7	R. Rocker Panel, Inside

Scratch	C3			
8	L. Front Quarter Panel, List

Loose	C3			
9	R. Rear Quarter Panel

Scratch	C3
