VEHICLE DESCRIPTION - Škoda Kamiq Selection 1.0 TSI

SUMMARY OF THE VEHICLE'S CONDITION

## OVERVIEW OF DAMAGES AND SHORTAGES

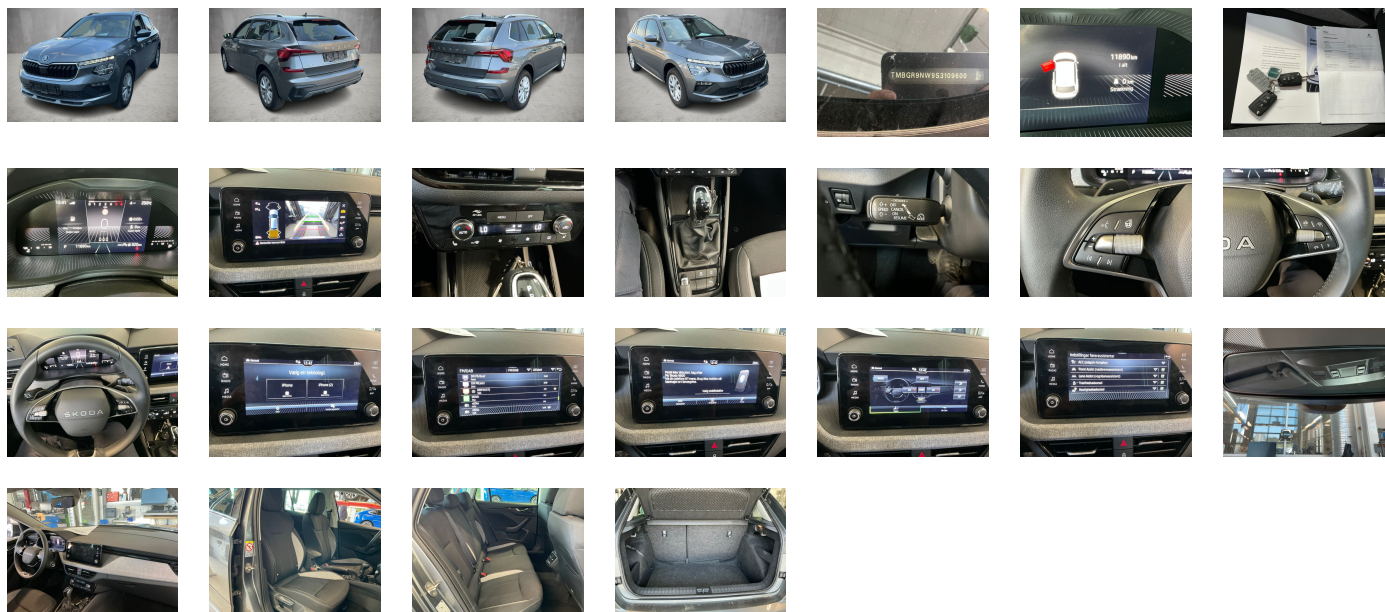
## PICTURES

| N° | LOCATION | TYPE | SEVERITY | INSURANCE | NOTES | DAMAGE GROUP |
|---|---|---|---|---|---|---|
| 1 | Rear Bumper | Scratch | C4 | | Reporting needed | |
| 2 | R. Front Quarter Panel | Scratch | C4 | | Reporting needed | |
| 3 | L. Front door | Scratch | C3 | | | |
| 4 | Rear Hood | Dent | C3 | | | |
