VEHICLE DESCRIPTION - Škoda Karoq Selection 1.5 TSI

SUMMARY OF THE VEHICLE'S CONDITION

## OVERVIEW OF DAMAGES AND SHORTAGES

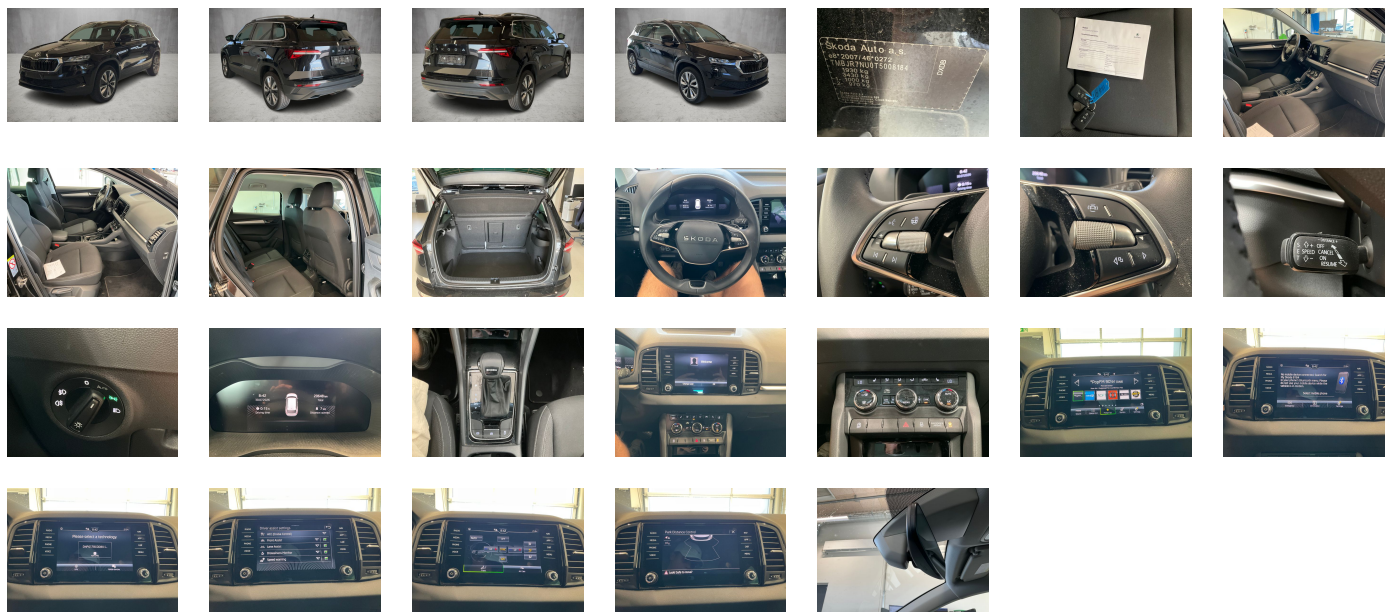
## PICTURES

| N° | LOCATION | TYPE | SEVERITY | INSURANCE | NOTES | DAMAGE GROUP |
|---|---|---|---|---|---|---|
| 1 | R. Rear Door | Dent | C4 | | Reporting needed | |
| 2 | R. Front Rim | Scratch | C4 | | Reporting needed | |
| 3 | L. Roof Pillar, C-Pillar | Scratch | C3 | | | |
| 4 | L. Front door | Scratch | C3 | | | |
| 5 | Rear Bumper | Scratch | C3 | | | |
